**Instytut Techniki Budowlanej (ITB)**

## TESTS REPORT

**LZP02-01036/23/R756NZP/ENG**

Curtain wall straight specimen in full configuration of  
**Aluprof MB-SR50N EI EI60 system**, heating from the  
**outside**

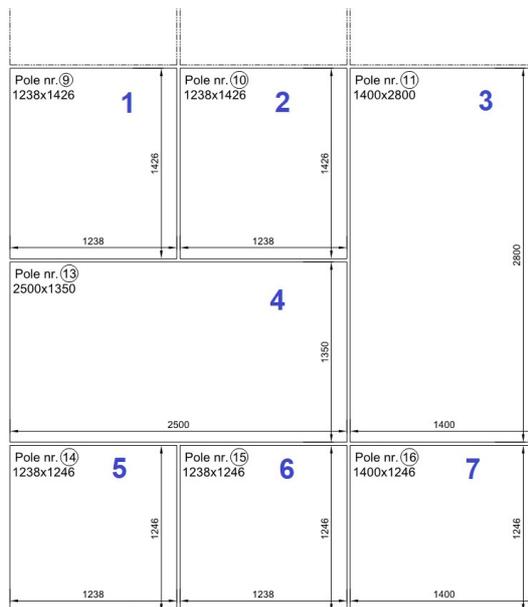
**Thickness of fire-resistant glazed units (average of 4 measurements)**

Glass nr 1	71,5
Glass nr 2	71,4
Glass nr 3	71,3
Glass nr 4	71,4
Glass nr 5	71,2
Glass nr 6	71,0
Glass nr 7	71,4

Time	Record
0m 0s	Commencement of the test
1m 41s	Internal layers of glass panes 1-7 break and fell into the furnace (glass number in as in point 2.2.1.);
36m 23s	Bubbles appear on the outer surface of the glass panes;
68m 36s	Termination of the test (reason: in agreement with the Client)

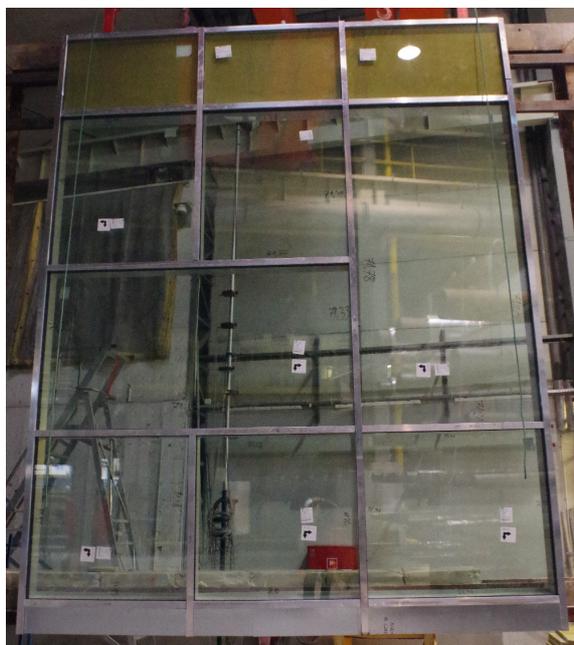
Fig. 1. Test specimen before the test – exposed side (before facing the furnace)

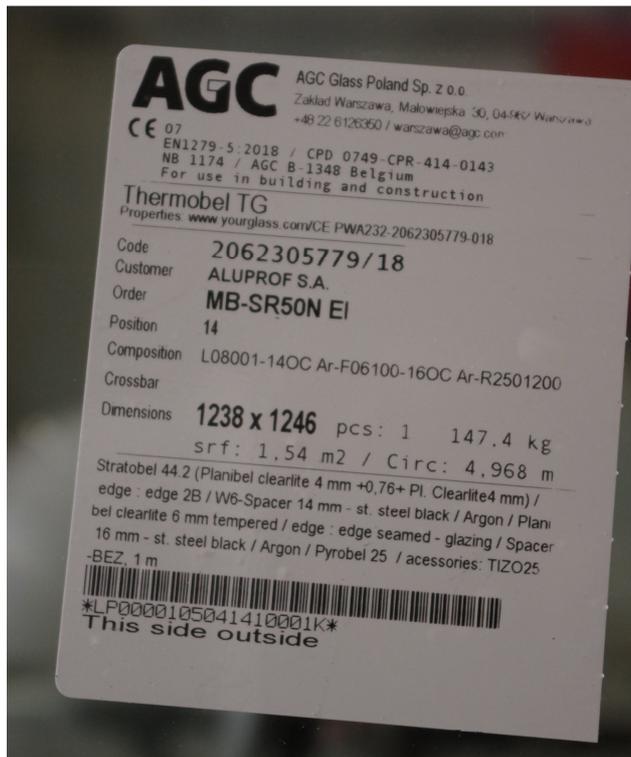
Fig. 2. Test specimen before the test - detail

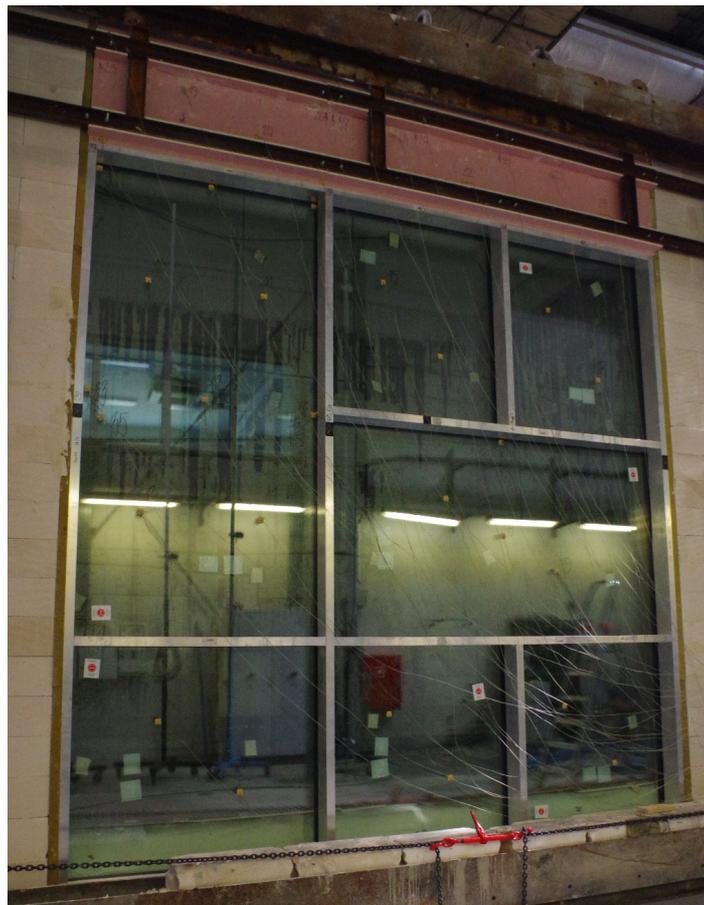
Fig. 3 Test specimen before the test - exposed side

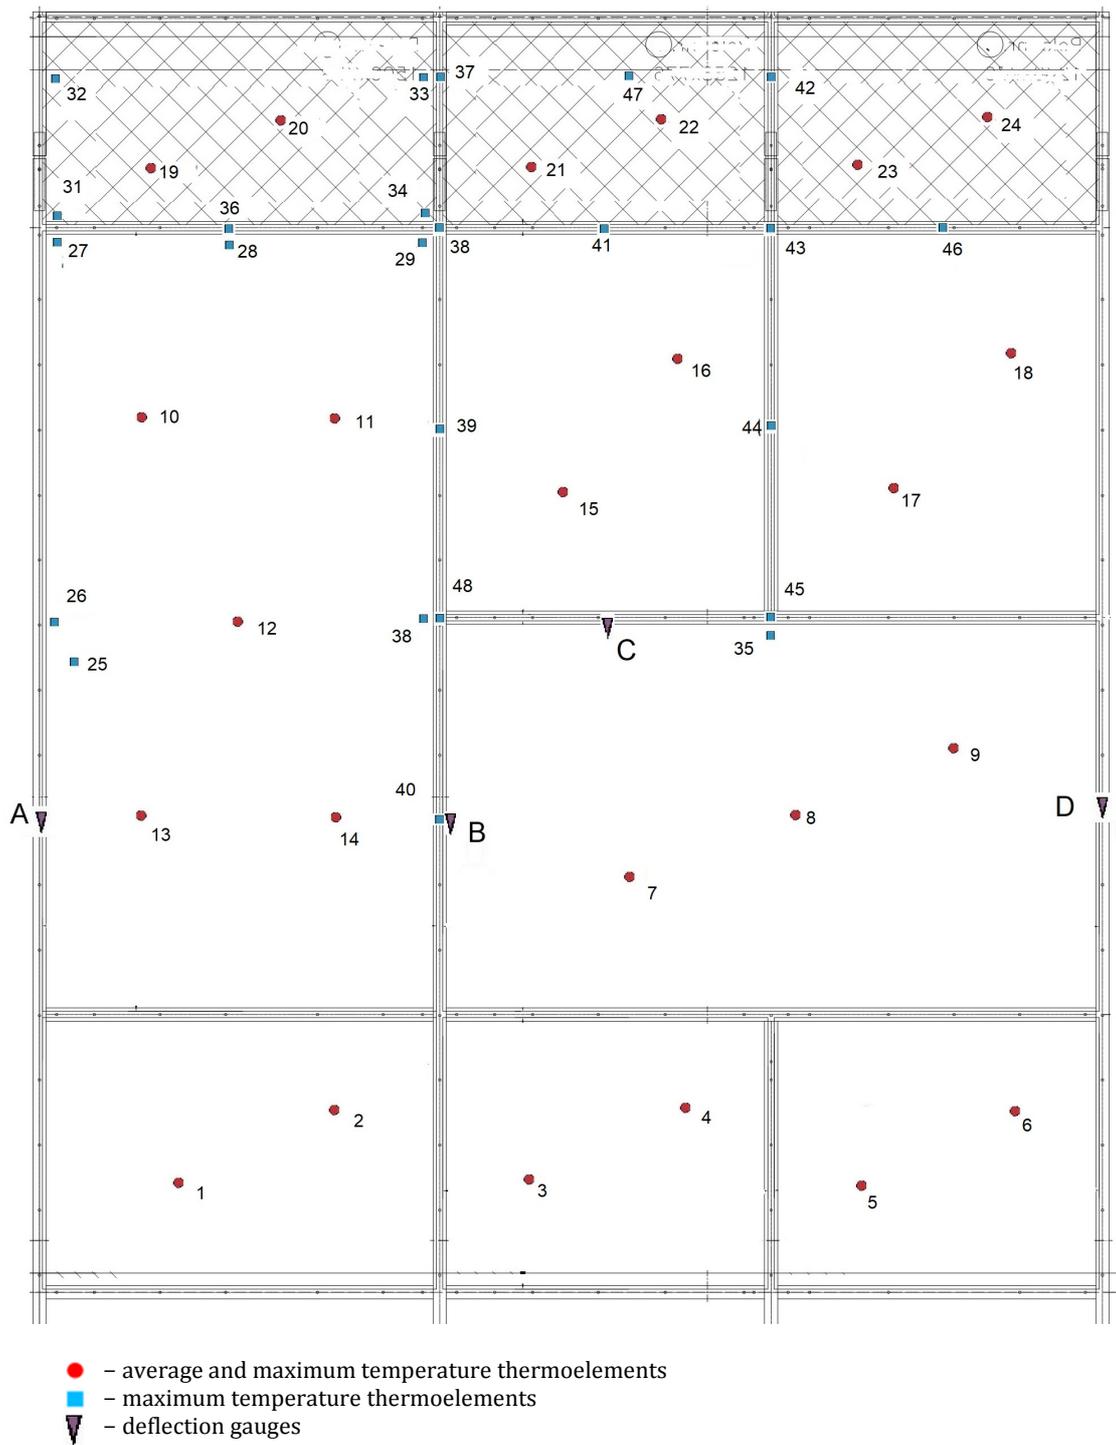
Fig. 3. Location of measurement points on unexposed side of the test specimen

<b>Location of measurement points:</b>	Fig. 4
<b>Furnace temperature:</b>	fig. 5, external curve
<b>Initial temperatures:</b>	
<b>furnace:</b>	25,6°C, (25,6°C ≤ 50°C)
<b>test specimen:</b>	24,4°C, (10°C ≤ 24,4°C ≤ 40°C)
<b>unexposed surface:</b>	24,4°C
<b>Heating tolerance:</b>	Fig. 6
<b>Furnace pressure:</b>	Fig. 7, measurement at the reference point 20 Pa
<b>Ambient temperature:</b>	fig. 8

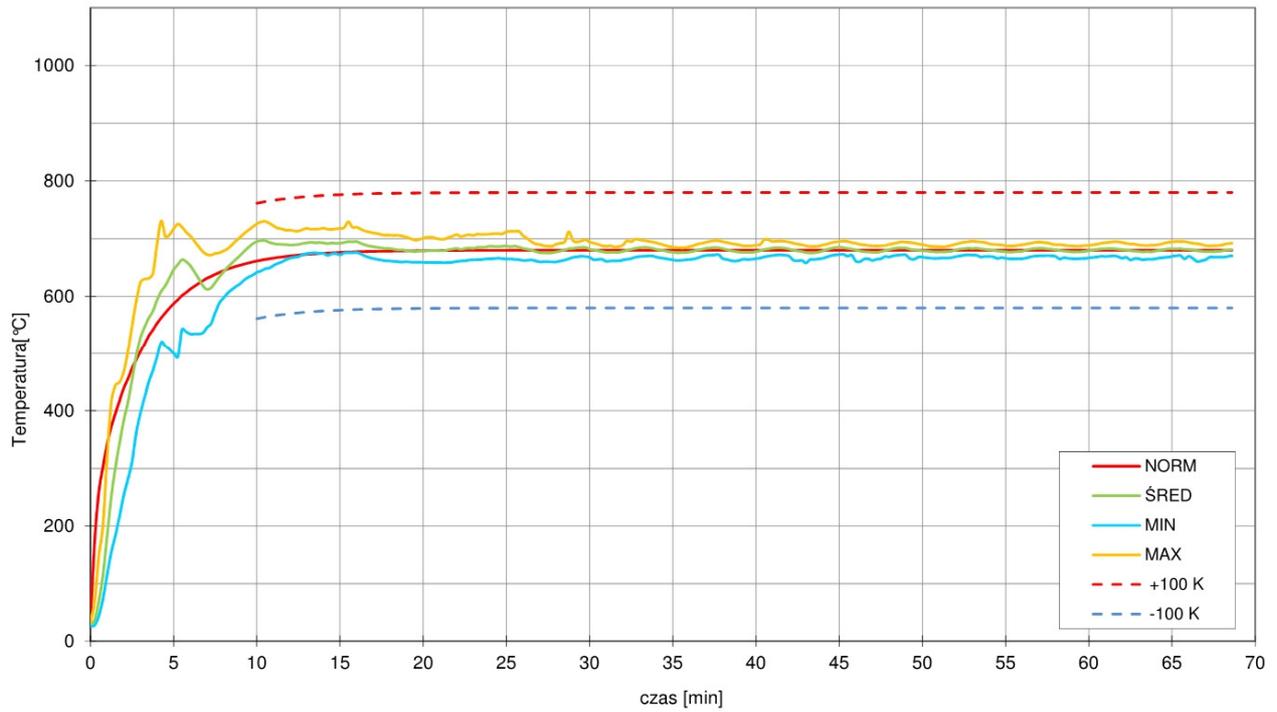
Fig. 5. Temperature of furnace heating conditions

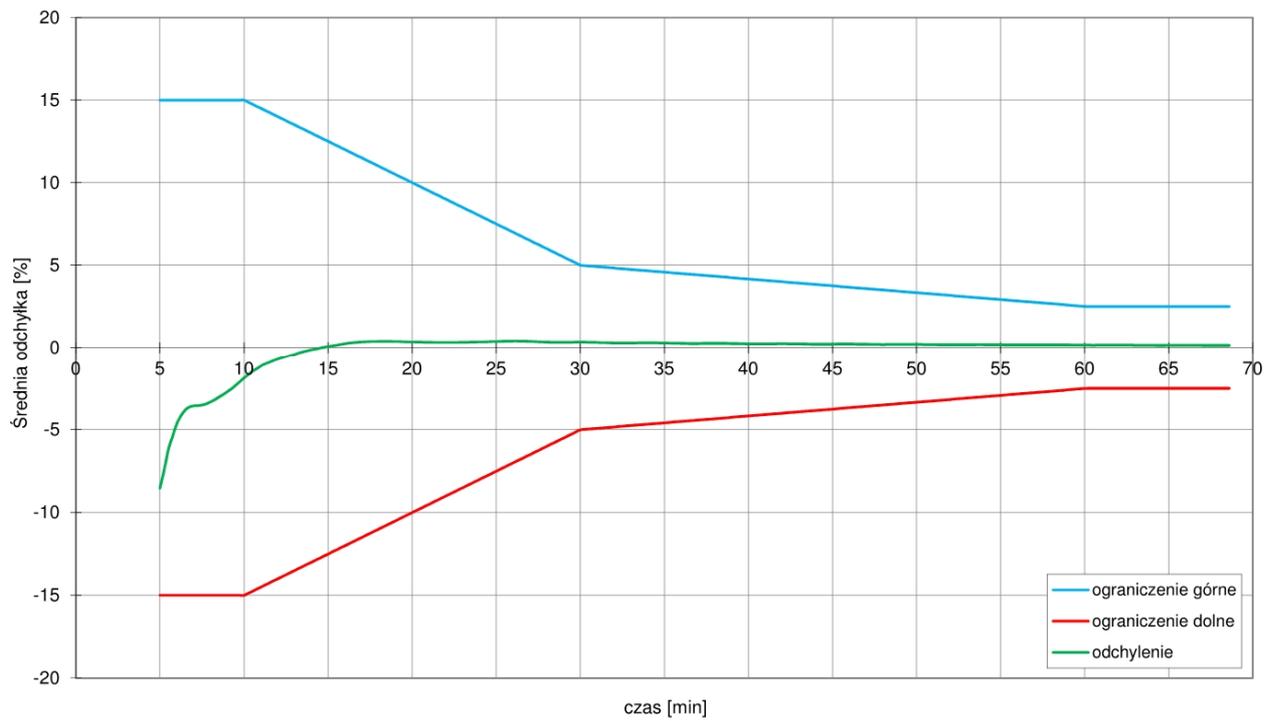
Fig. 6. Tolerance of heating

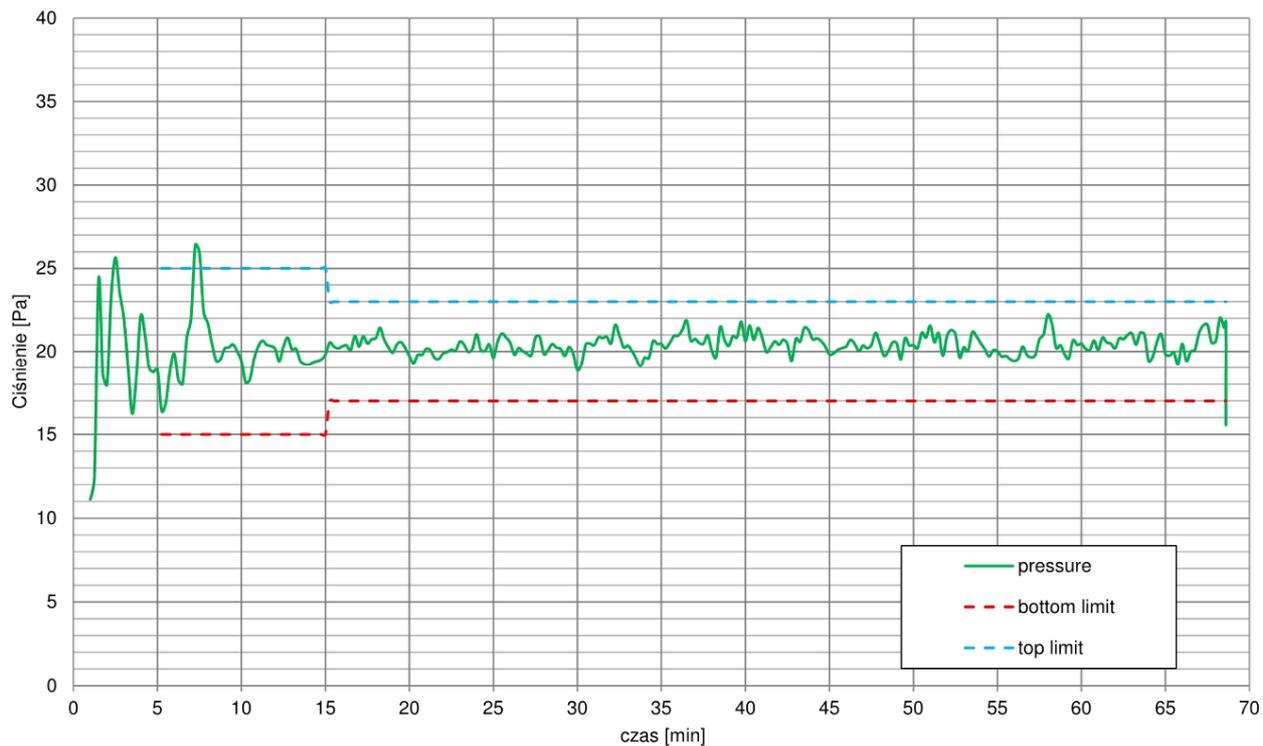
Fig. 7. Furnace pressure

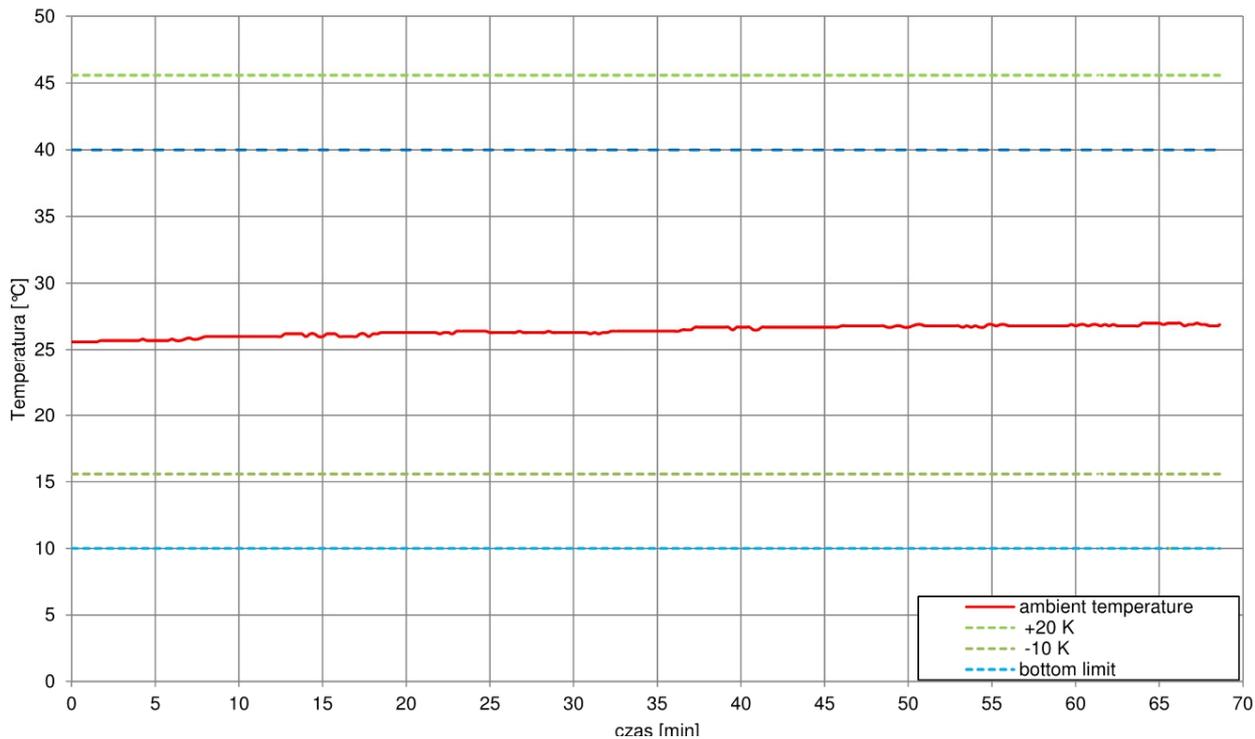
Fig. 8. Ambient temperature

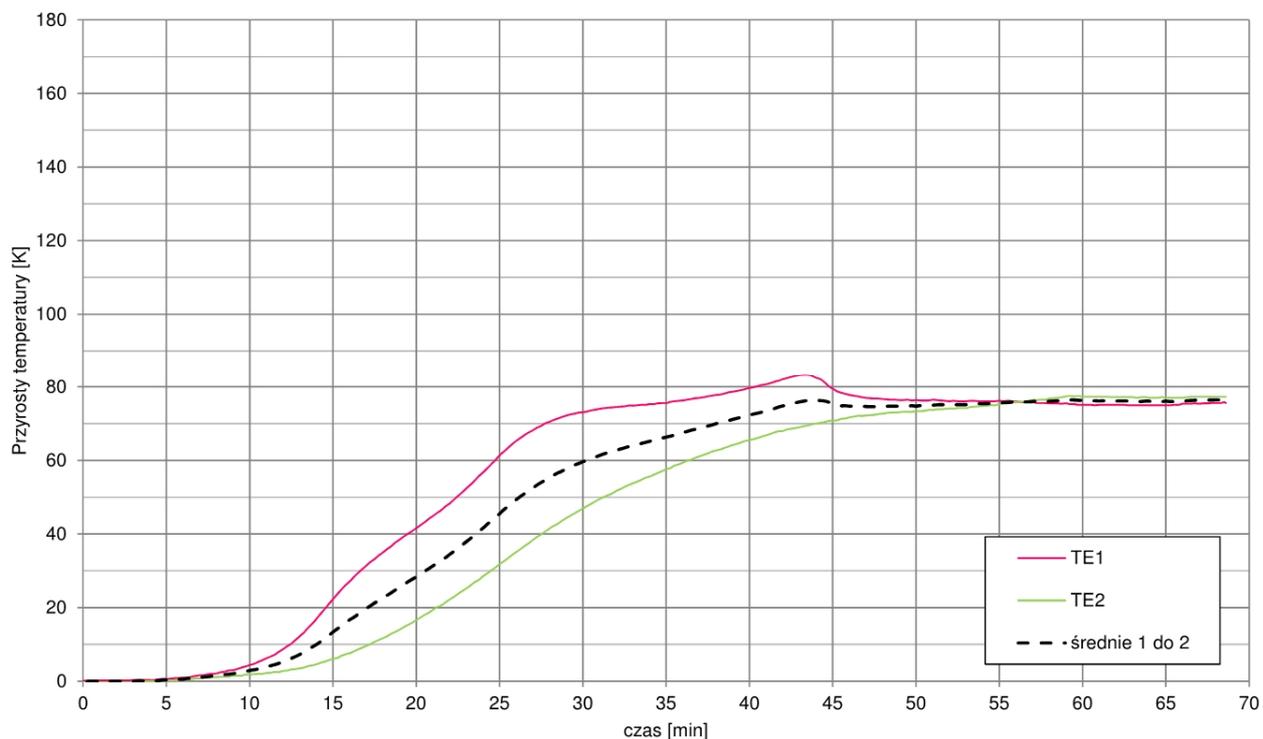
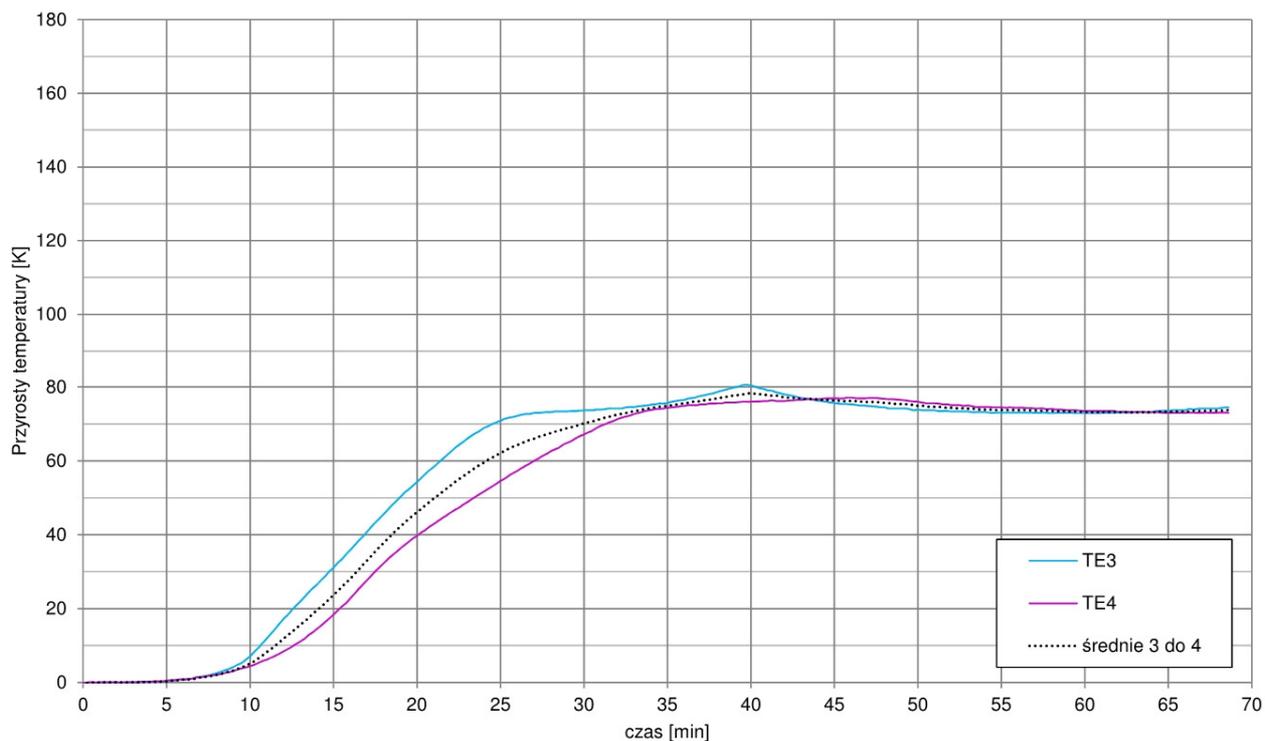
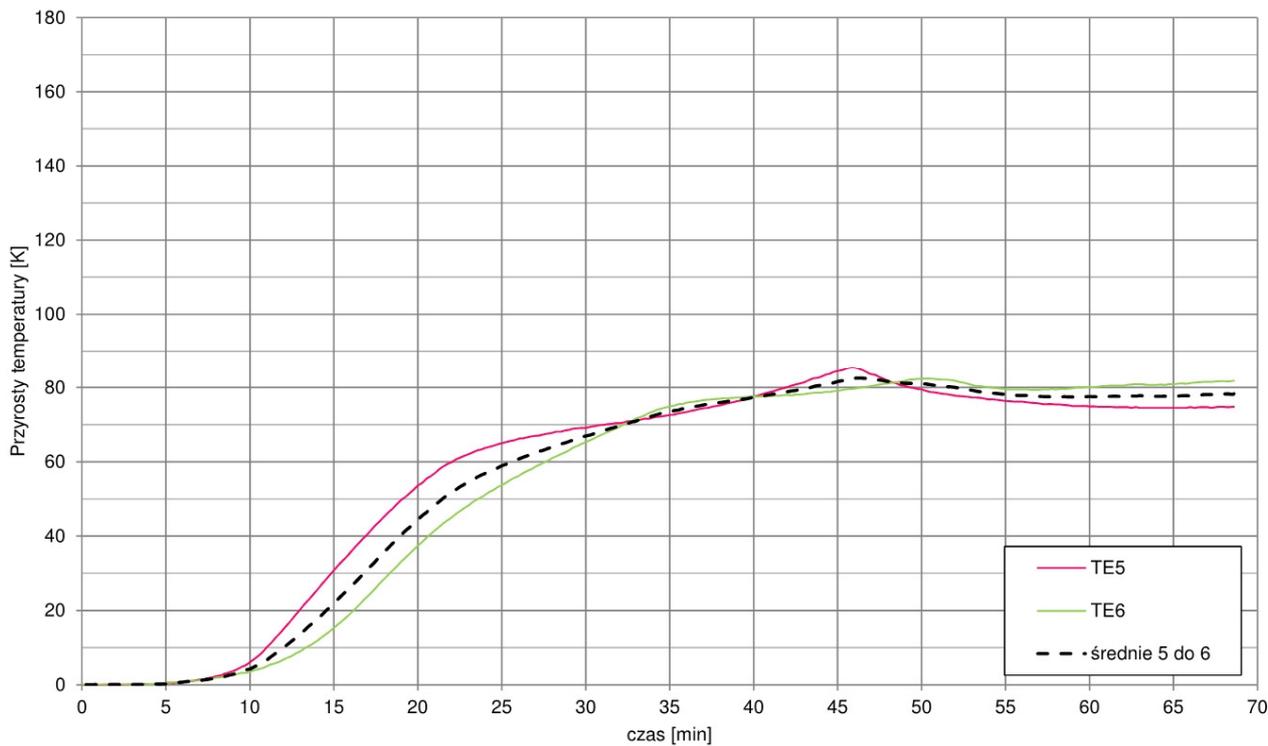
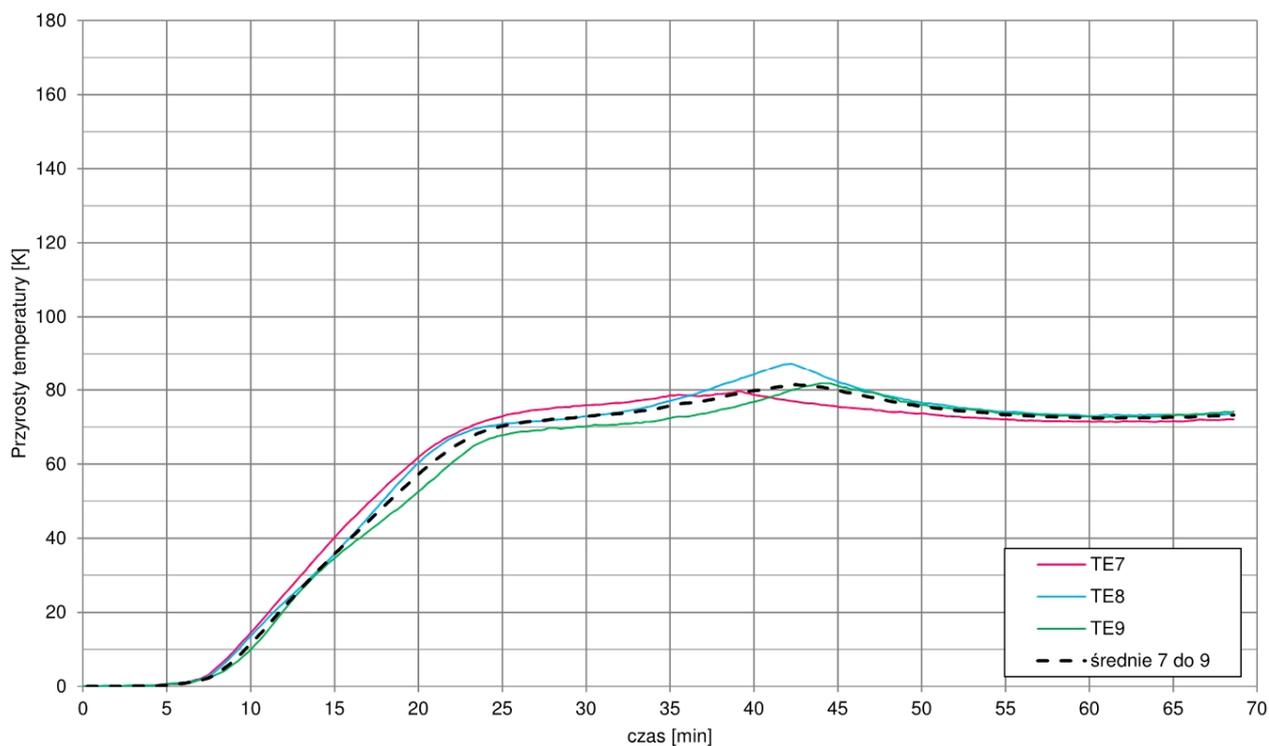
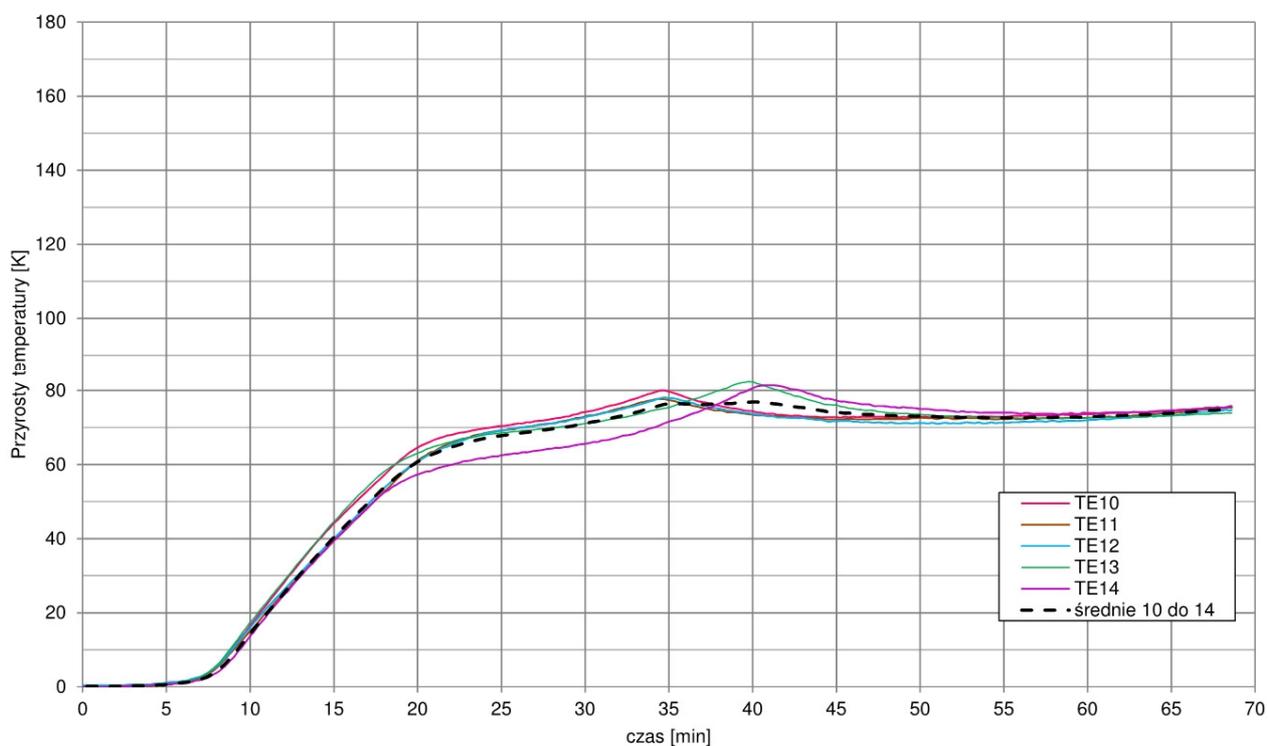
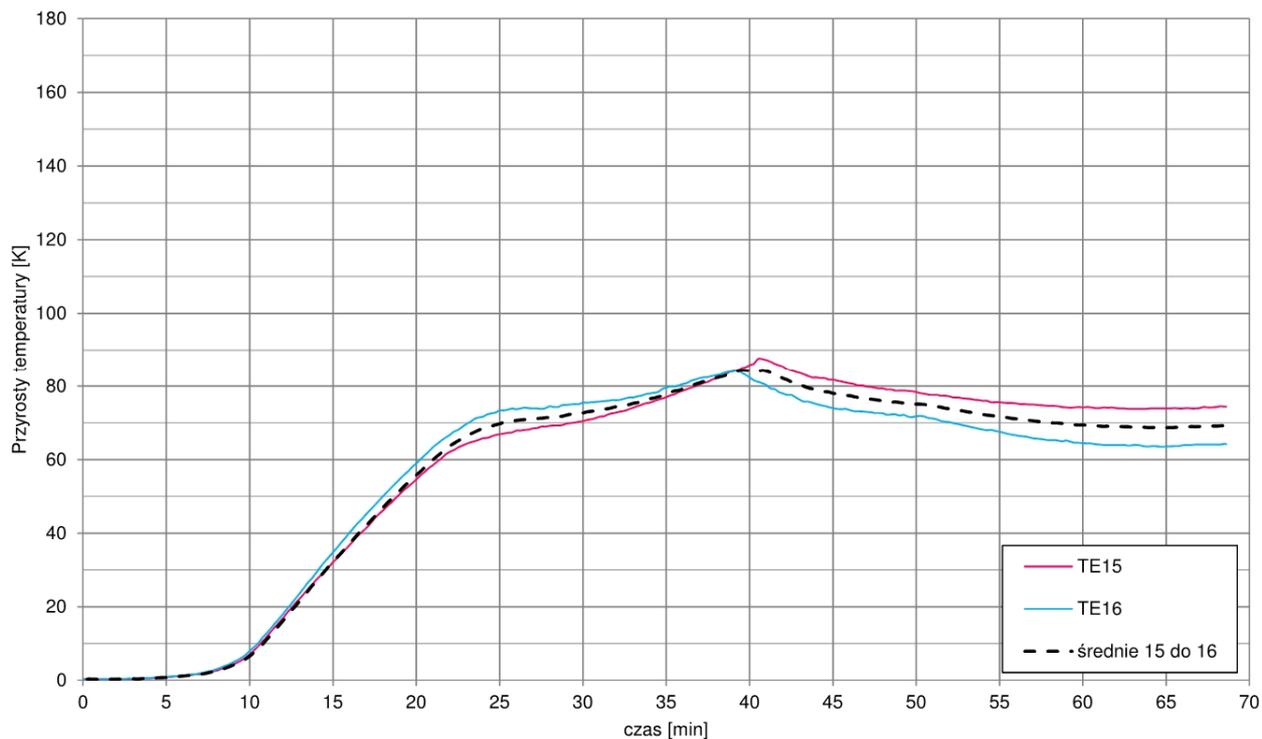
Fig. 9. Temperature rise on the unexposed surface of the test specimen – average and maximum temperature thermoelements

**Temperature risen on the unexposed surface:** Fig. 9 -23

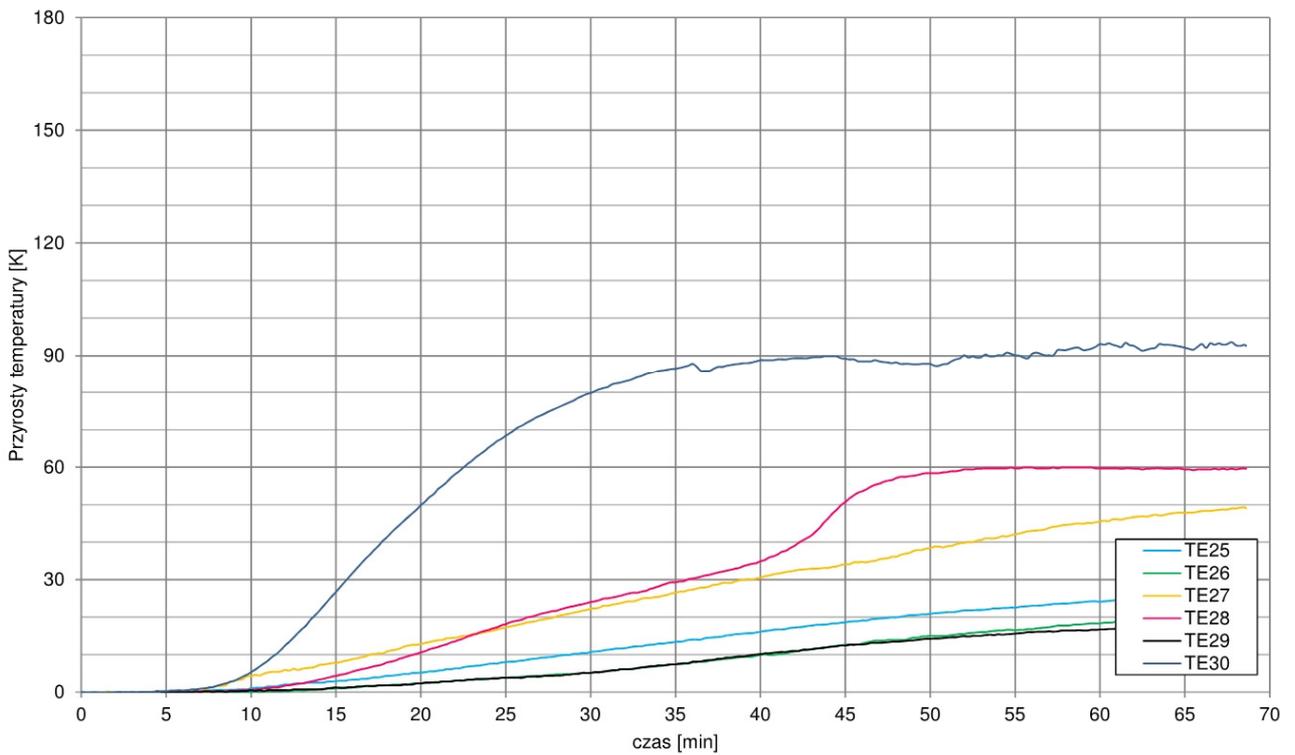
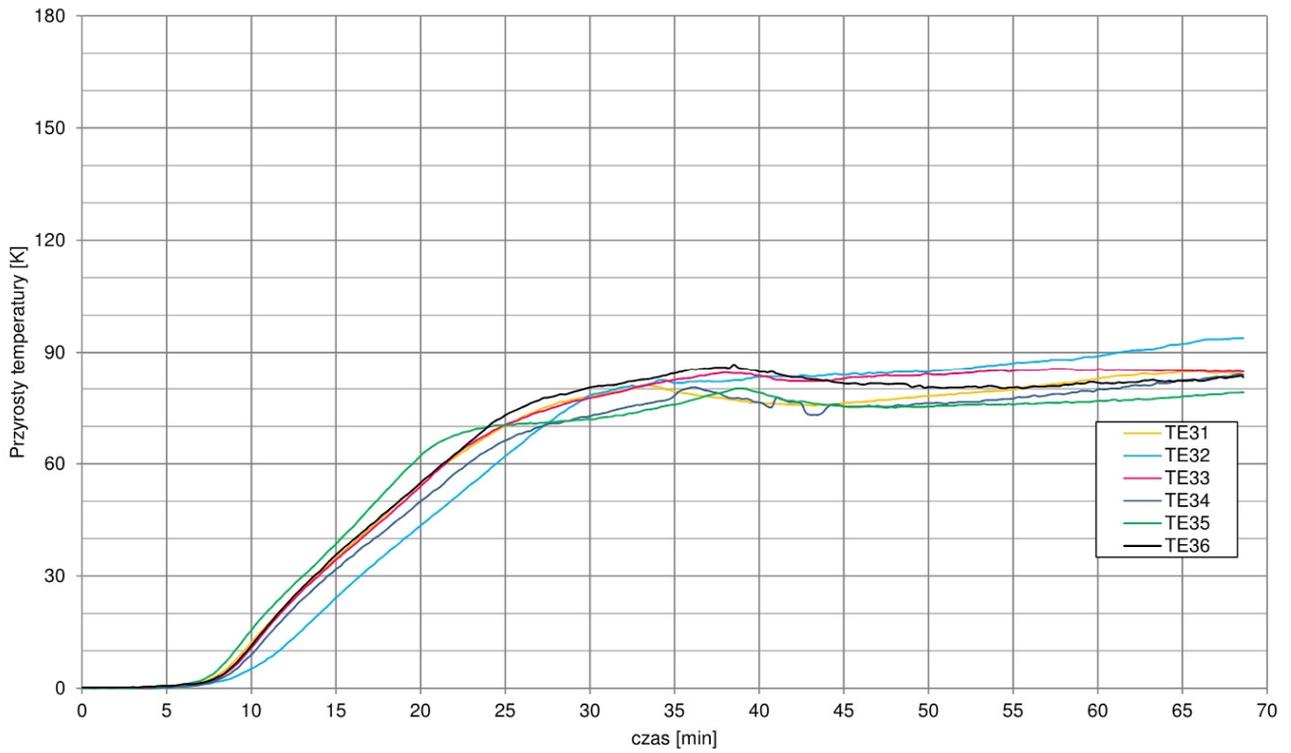
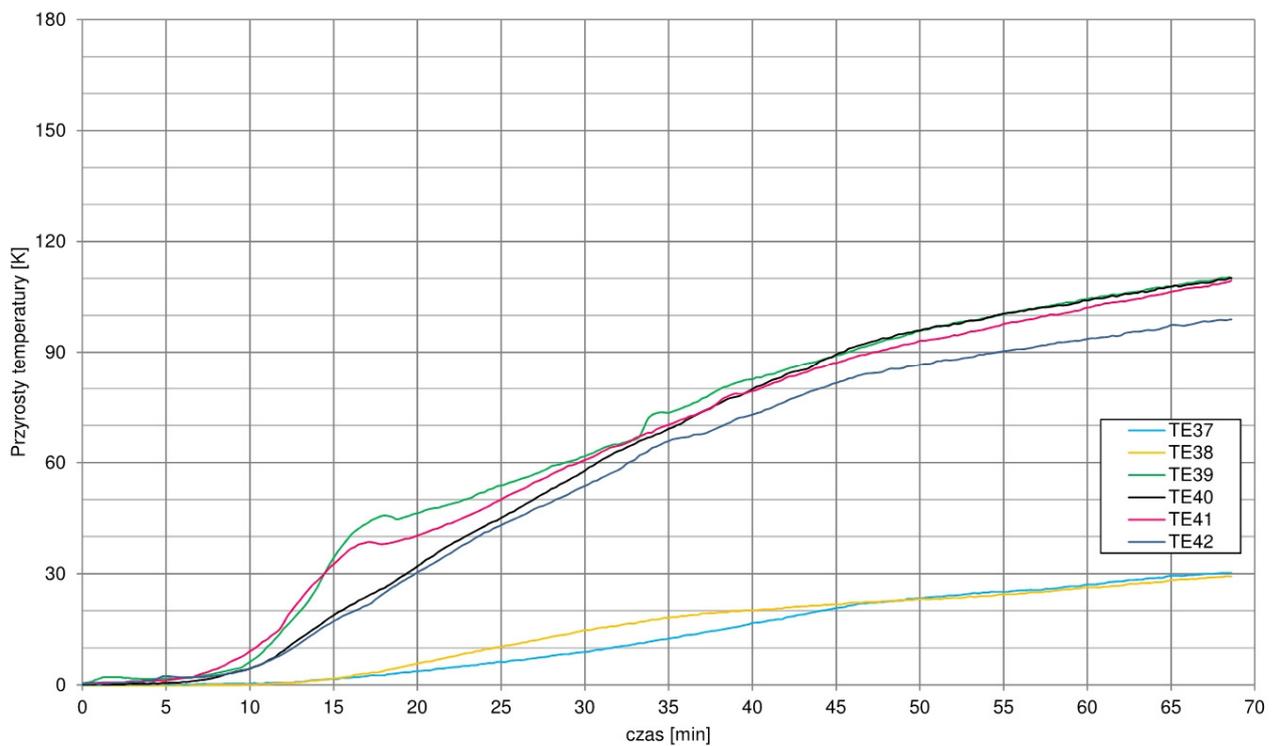
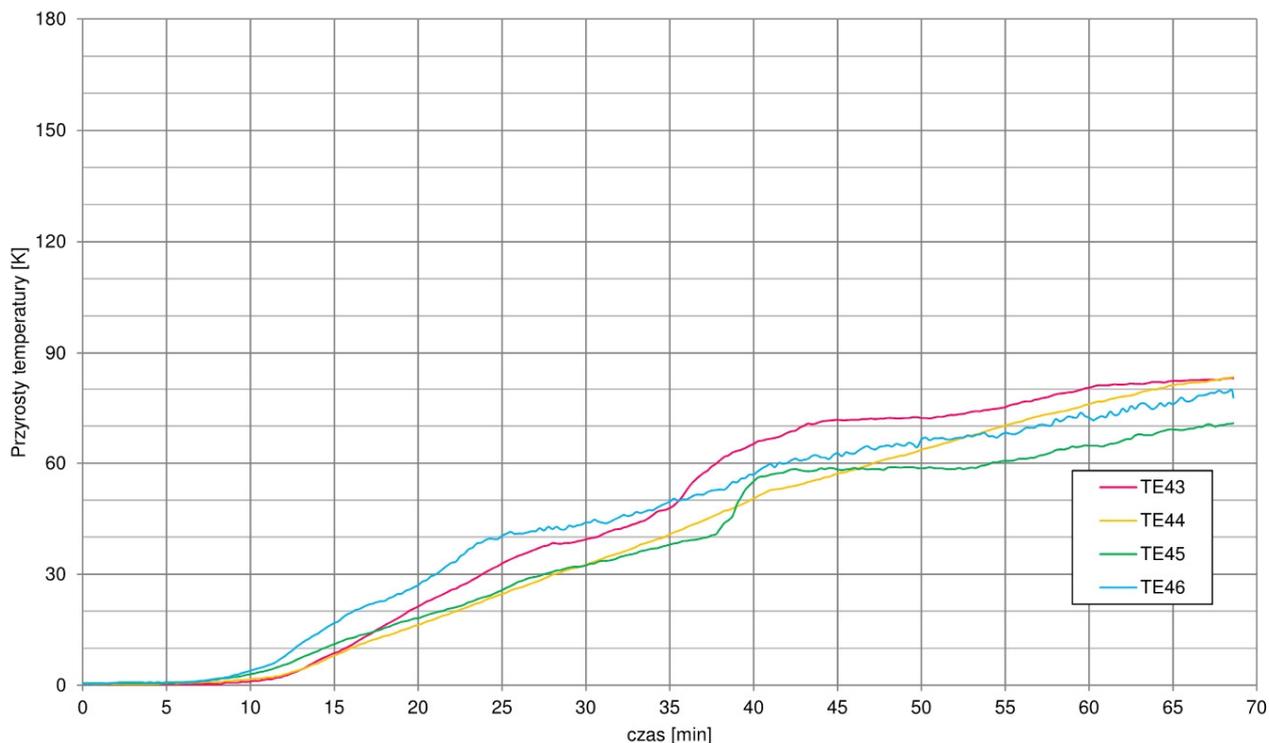
Fig. 19. Temperature rise on the unexposed surface of the test specimen – maximum temperature thermoelements

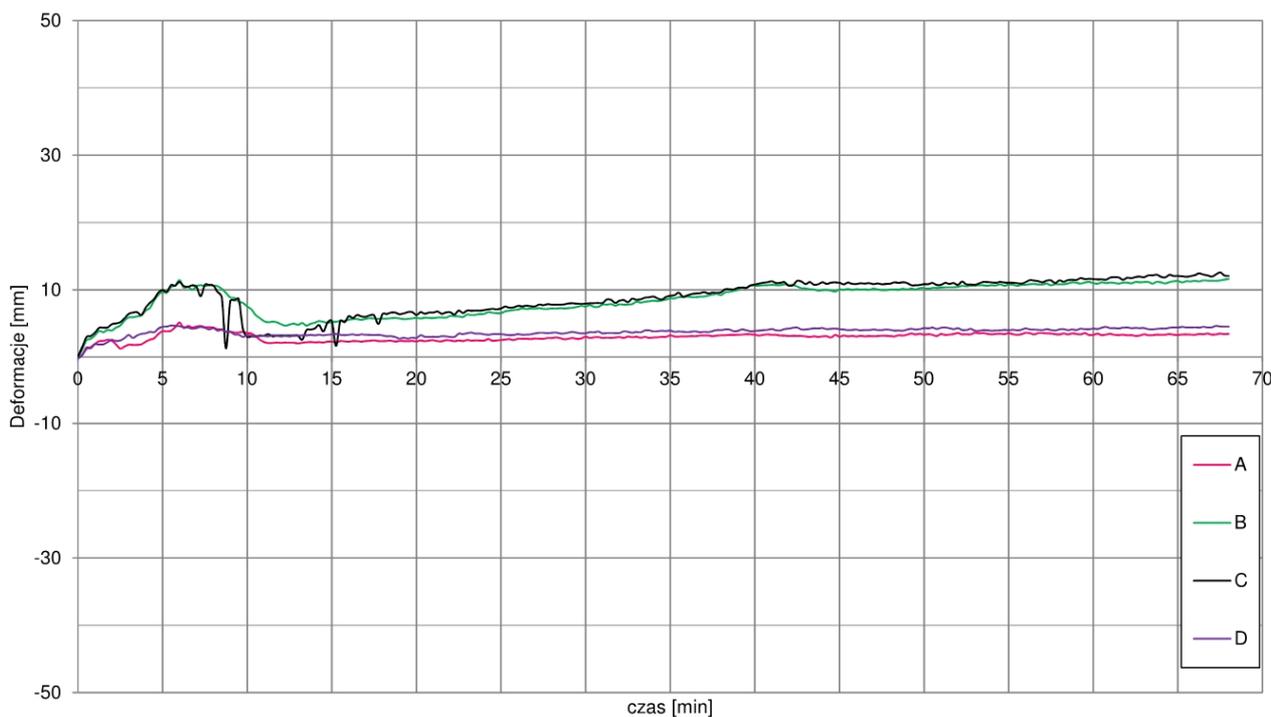
The places of measurement of deflection of the curtain wall perpendicular to its surface are shown in Fig. 5. The values of the measured displacements are shown in Fig. 23 below.

Displacements towards the inside of the furnace – negative displacements.

Movements towards the outside of the furnace – positive displacements.

Fig. 23. Test specimen deflections

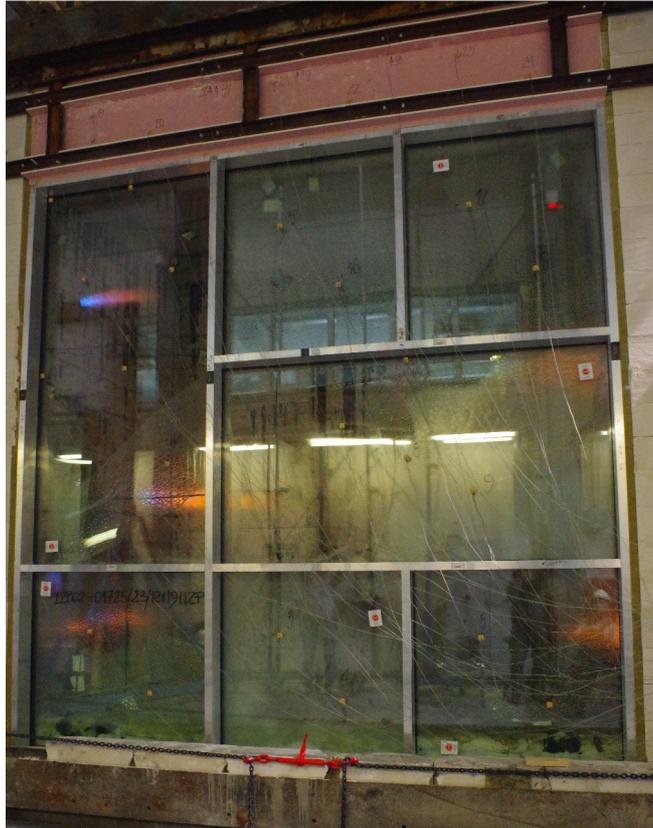
Fig. 24. Unexposed side of the test specimen,  $t = 4$  m

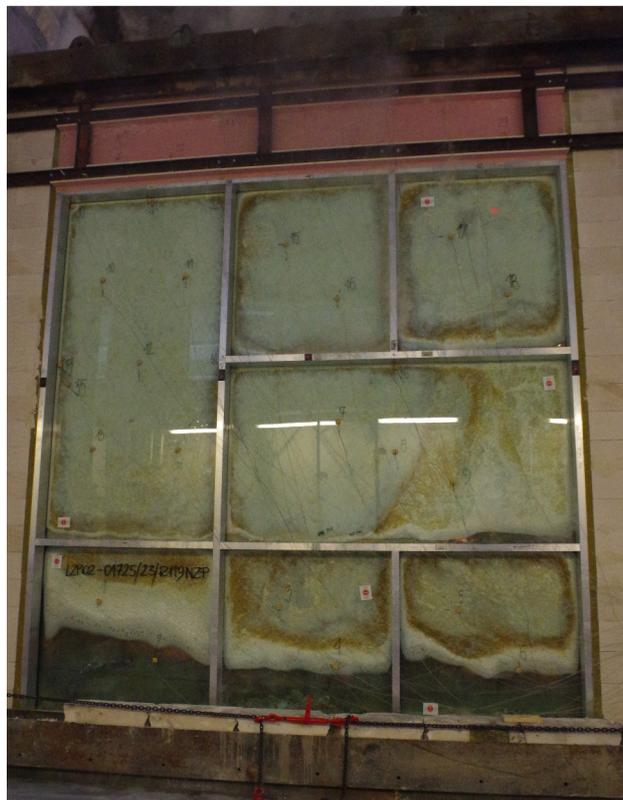
Fig. 25. Unexposed side of the test specimen,  $t = 15$  m

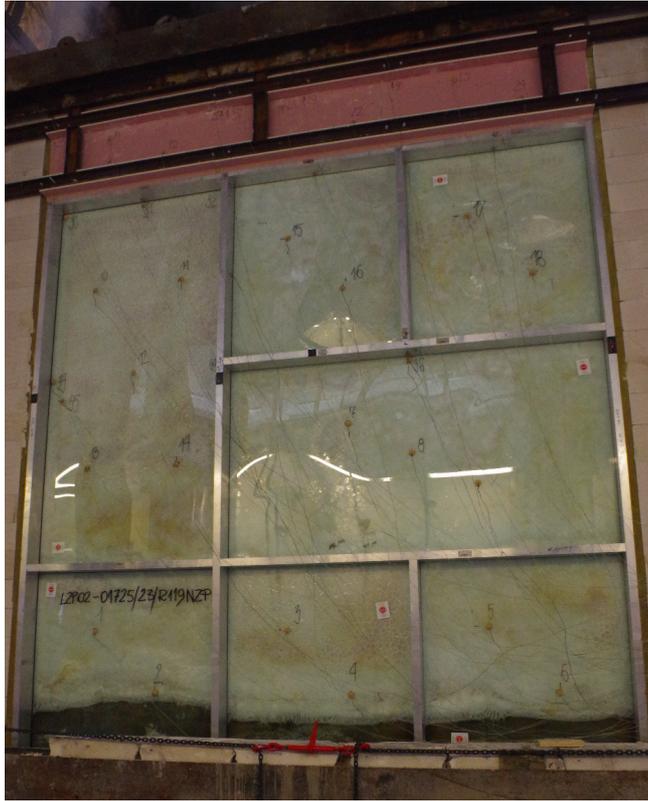
Fig. 26. Unexposed side of the test specimen,  $t = 41$  m

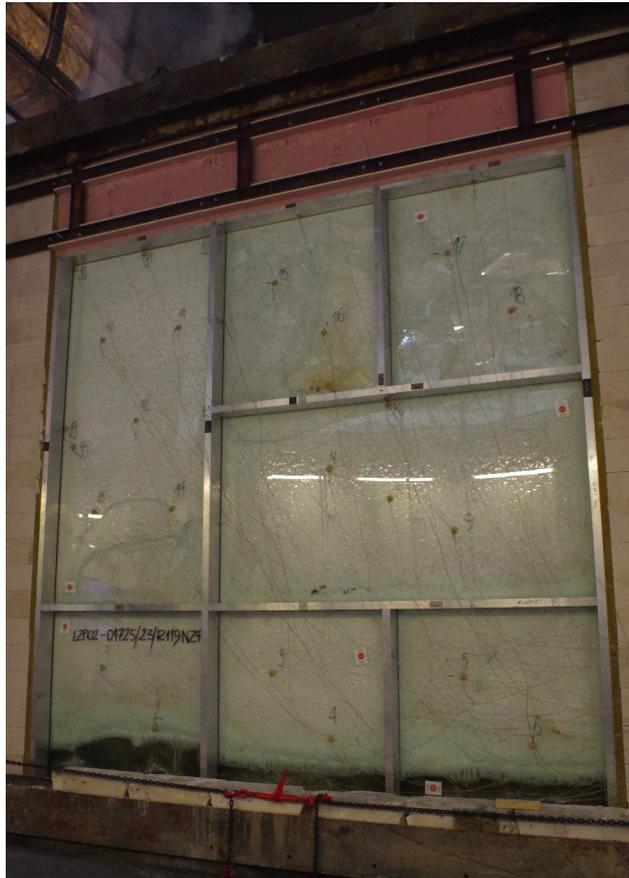
Fig. 27. Unexposed side of the test specimen,  $t = 61$  m

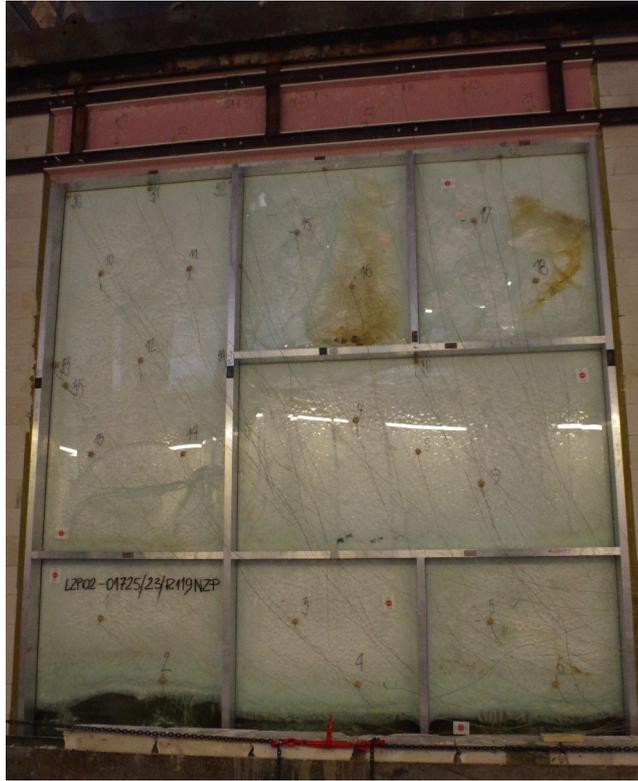
Fig. 28. Unexposed side of the test specimen after the test

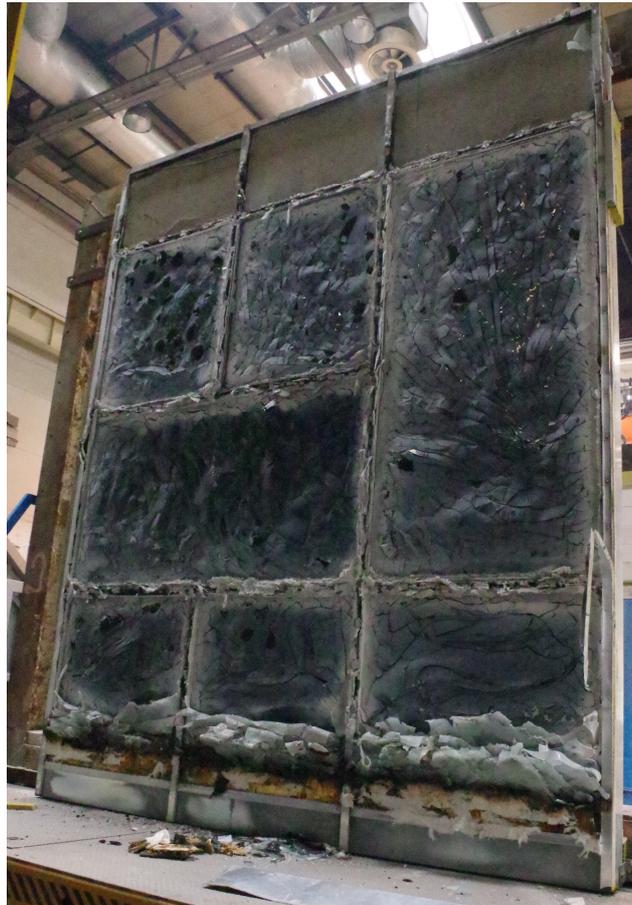
Fig. 29. Exposed side of the test specimen after the test

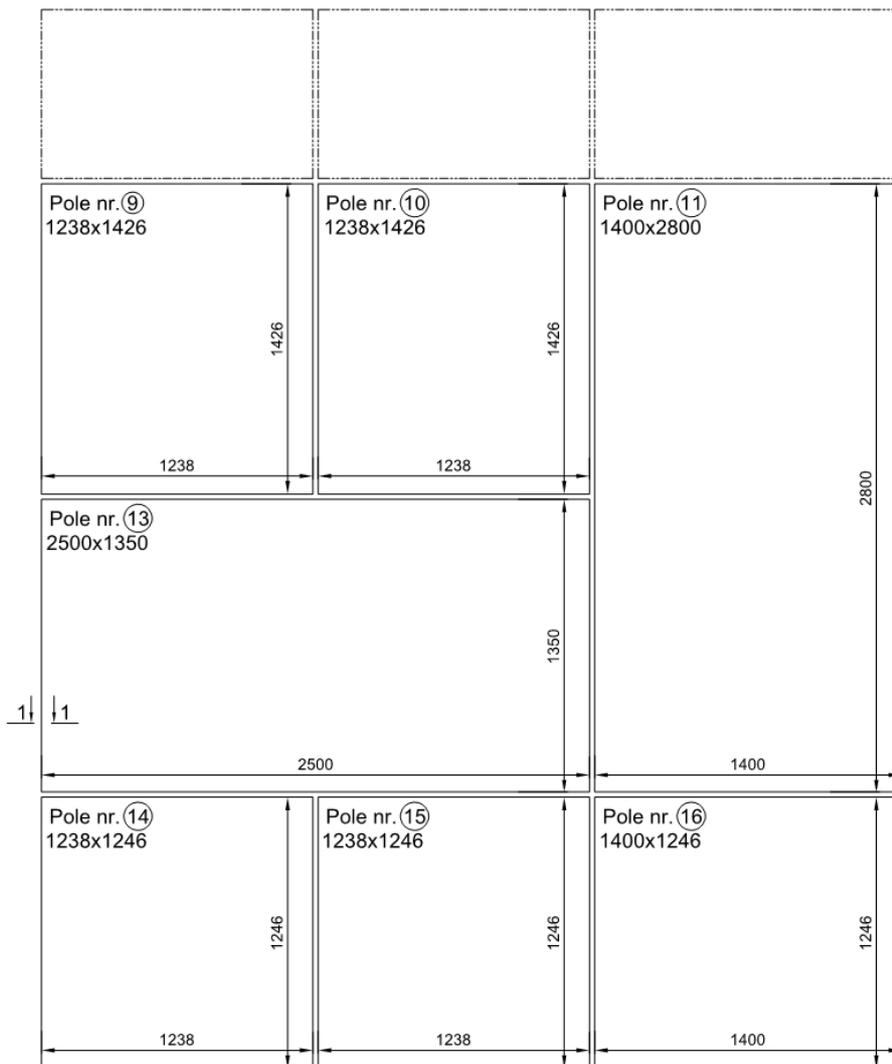
**UWAGA:**  
 1. Ilość szyb - 7  
 2. Krawędzie szyb szlifowane

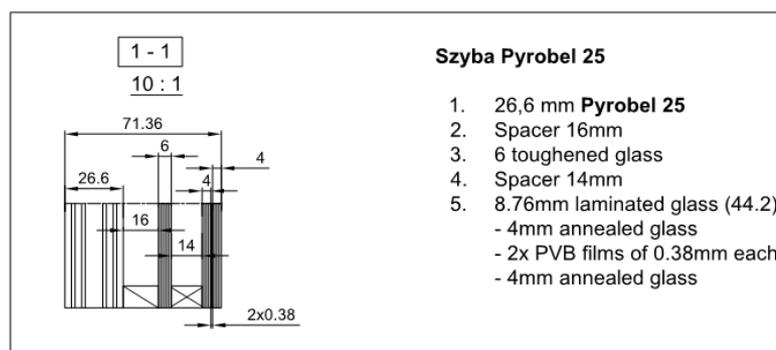
Fig. 2A. Transparent fillings

- Pyrobel 25 EI60 TGU glazing units with thickness of 71,36 mm (D)/ 70,7 -71,8 (M) mm with following structure (listed from the outside): VSG 44.2 mm / spacer frame 14 mm/ ESG 6 mm / spacer frame 16 mm / Pyrobel 25 EI60 manufactured by AGC with thickness 26,6 mm. The details of the glass dimensions and placement are shown in fig. 2A in Appendix A.
- in area of the inter-storey belt, panels with following structure: glazing unit: ESG 6 mm/ spacer frame 16 mm/ ESG 6 mm; 100 mm rock wool with density of 80 kg/m<sup>3</sup> type WENTIROCK manufactured by ROCKWOOL/ 0,80 mm steel sheet / 12,5 mm type F plasterboard.
