Instytut Techniki Budowlanej (ITB)

TESTS REPORT LZP02-01036/23/R742NZP/ENG

Curtain wall straight specimen in full cofiguracion of
Aluprof MB-SR50N EI EI30 system, heating from the
outside

Test method: EN 1364-3:2014, no deviations. External heating curve.

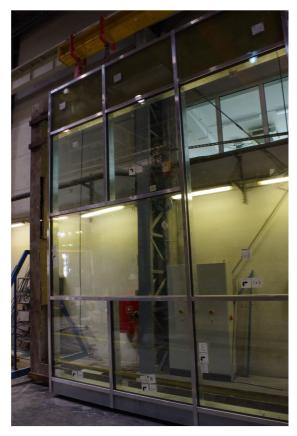
Fig. 1. Test specimen before the test – exposed side (before facing the furnace)

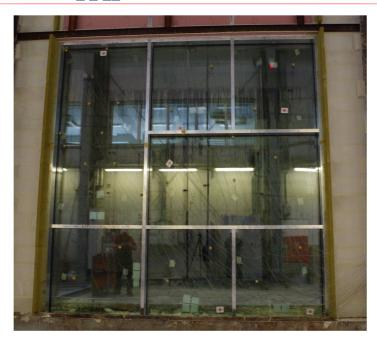
Fig. 2. Test specimen before the test - unexposed side

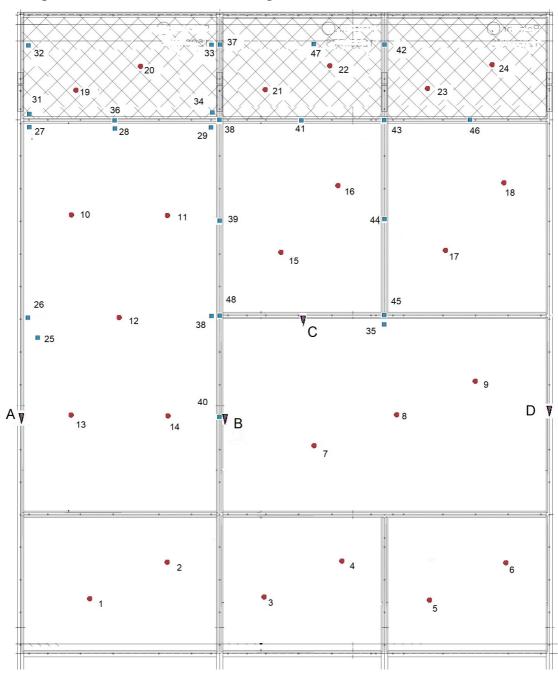
average and maximum temperature thermoelements

– maximum temperature thermoelements

deflection gauges

Fig. 3. Location of measurement points on unexposed side of the test specimen

Location of measurement points: Fig. 3

The places of measurement of deflection of the curtain wall perpendicular to its surface are shown in Fig. 5. The values of the measured deflection s are presented in the Table 1.

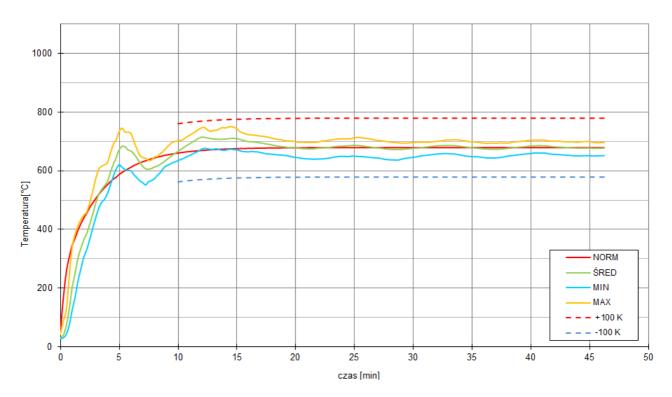
Fig. 4. Temperature of furnace heating conditions

Furnace temperature: fig. 4, external curve

furnace: $29,3^{\circ}\text{C}, (29,3^{\circ}\text{C} \le 50^{\circ}\text{C})$

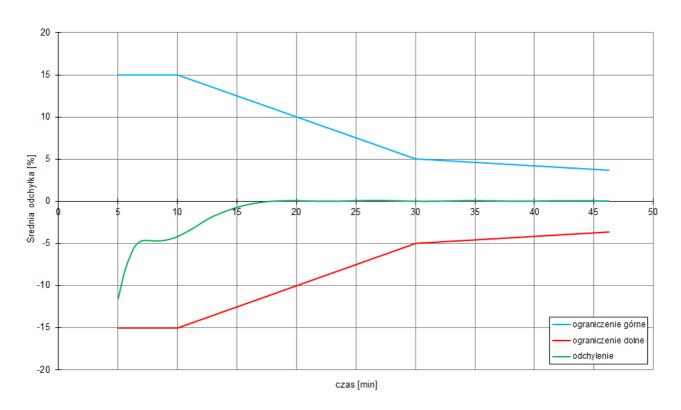
Fig. 5. Tolerance of heating

Heating tolerance: Fig. 5

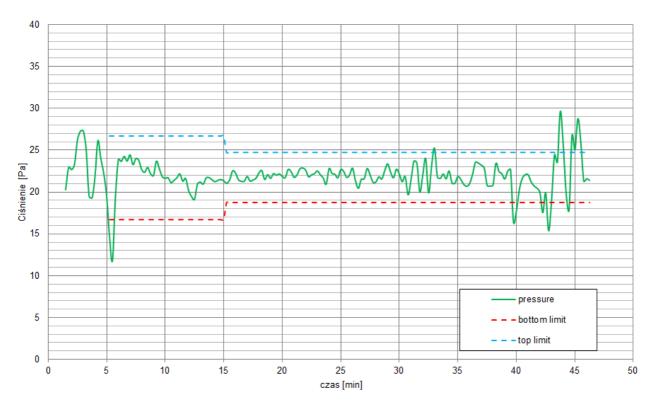
Fig. 6. Furnace pressure

Furnace pressure: Fig. 6, measurement at the reference point 20 Pa

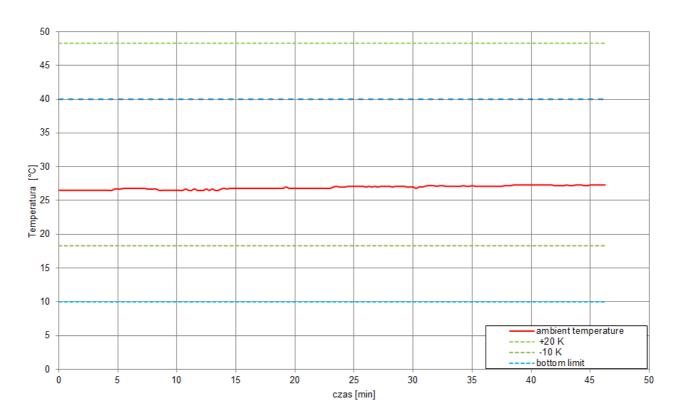
Fig. 7. Ambient temperature

Ambient temperature: fig. 7

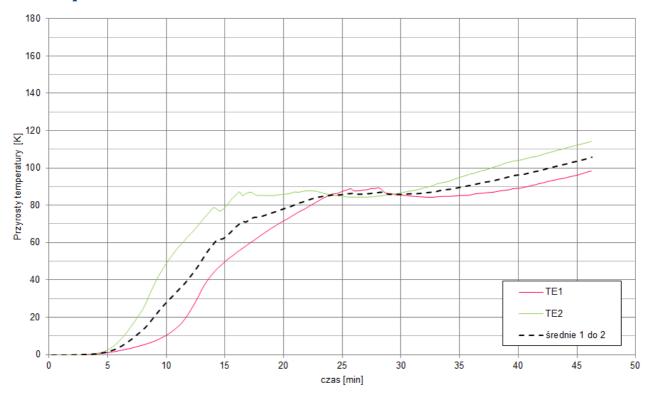
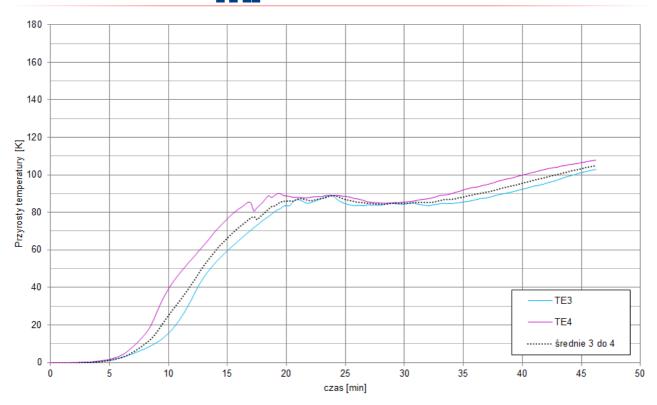
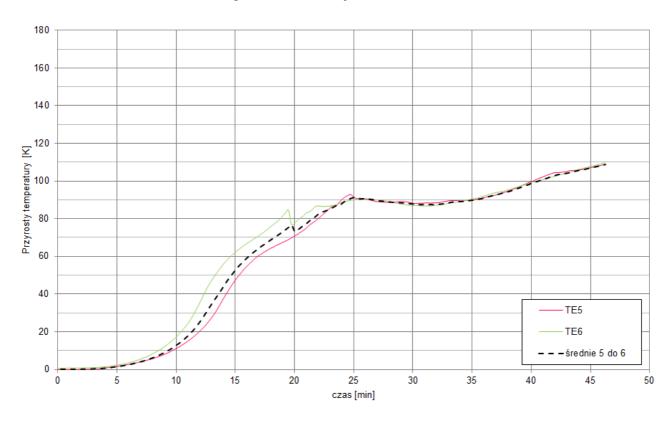
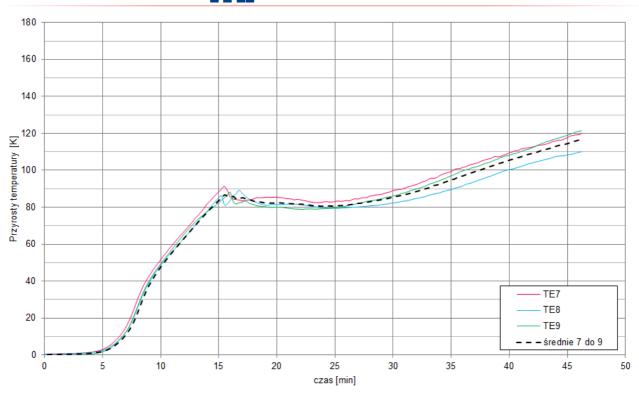
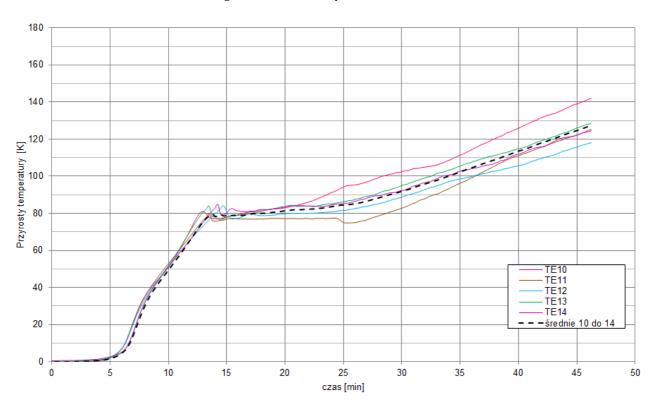
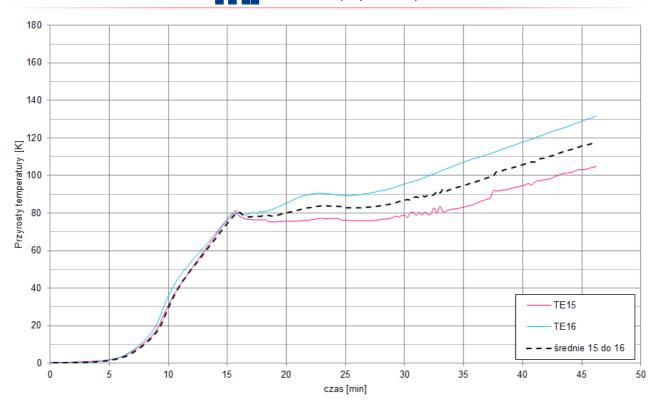
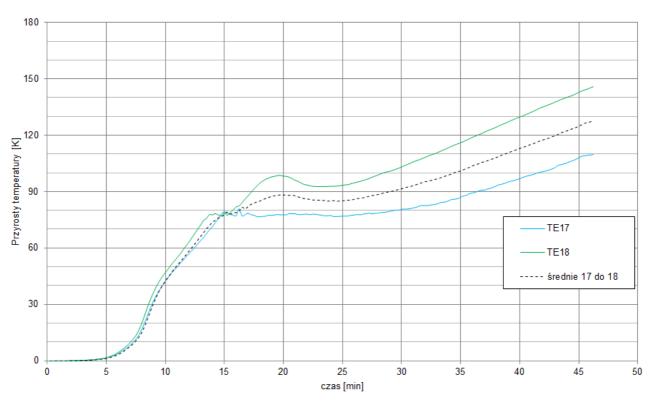
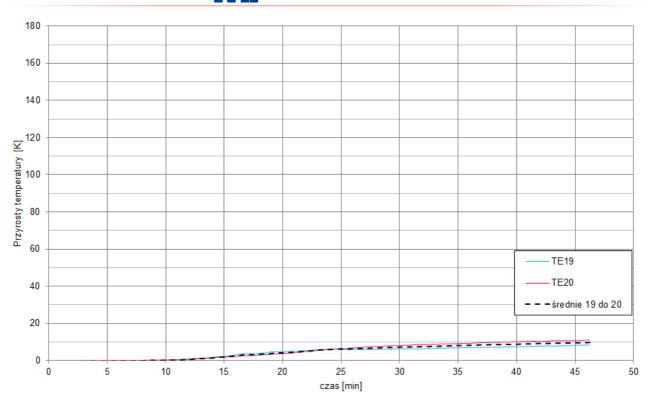
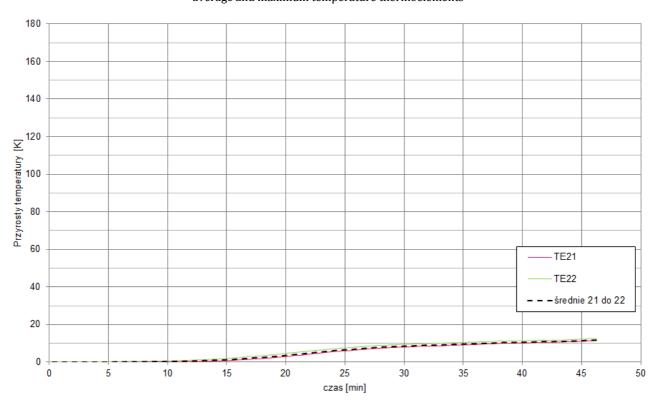
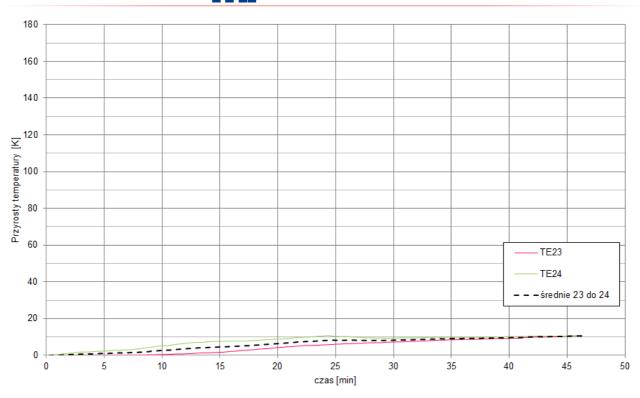
Fig. 8. Temperature rise on the unexposed surface of the test specimen – average and maximum temperature thermoelements

Temperature rised on the unexposed surface: Fig. 8 -21

Insulation performance (I)	Time	Location
Average temperature rise (140K)	47 min no failure	-
Maximum temperature rise – normal procedure	47 min no failure	-

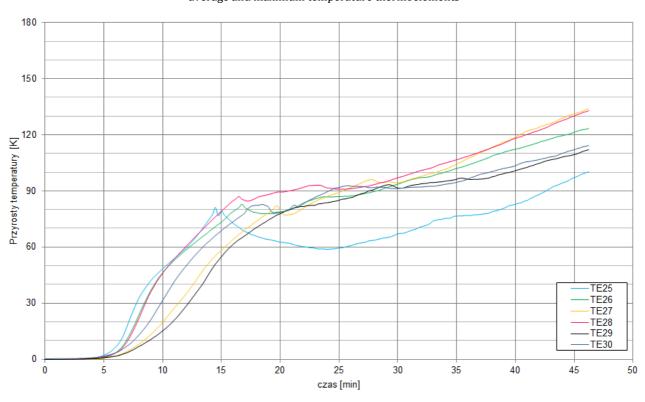
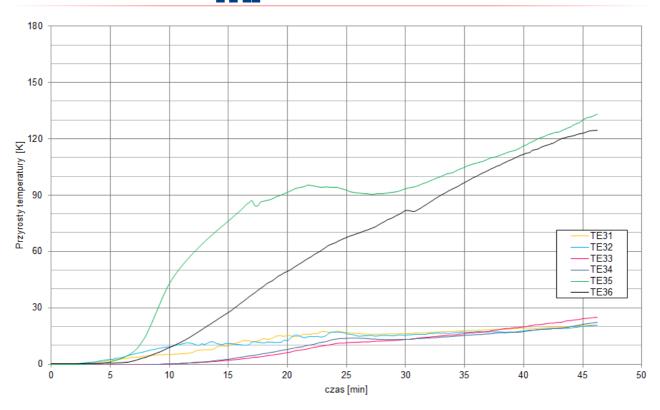
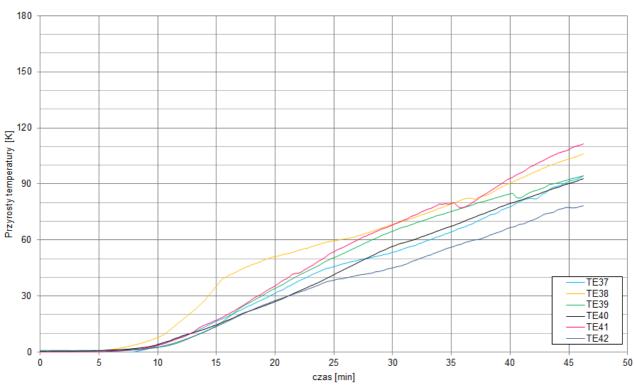
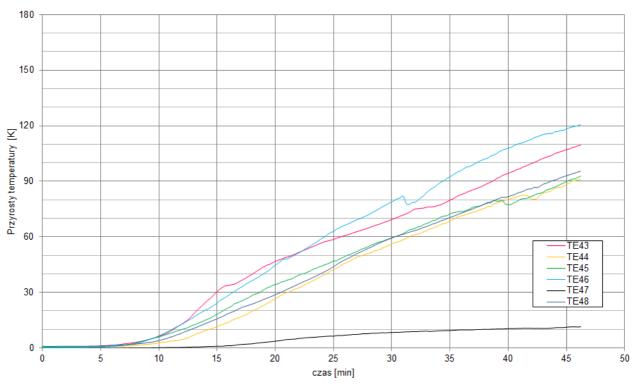
Fig. 18. Temperature rise on the unexposed surface of the test specimen – maximum temperature thermoelements

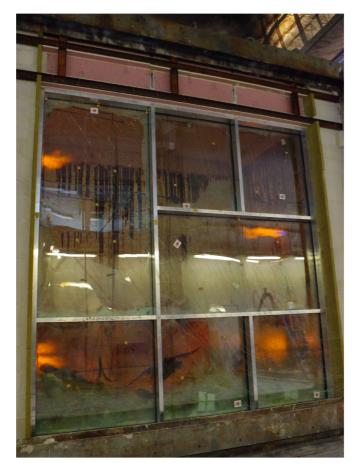
Fig. 22. Unexposed side of the test specimen, t = 6 m

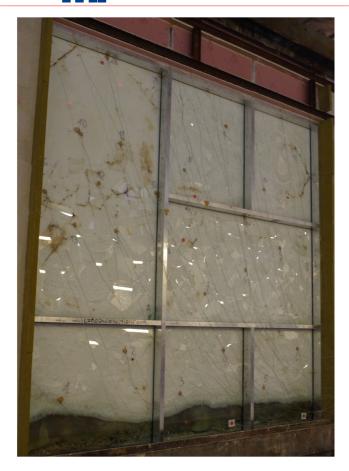
Fig. 24. Unexposed side of the test specimen, t = 46 m

Time	Record
0m 0s	Commencement of the test
15m 01s	Non-transparent glass panes.
16m 02s	Intense smoke along the the upper horizontal edge of glass panes No. 3 and No. 4 (glass numbering as in point 2.2.1.)
38m 20s	A dark spot forms on glass No. 6.
39m 54s	Moving thermocouple applied to the observation point describet at 38m 20s; TE = 117°C
47m 00s	Termination of the test (reason: in agreement with the Client)

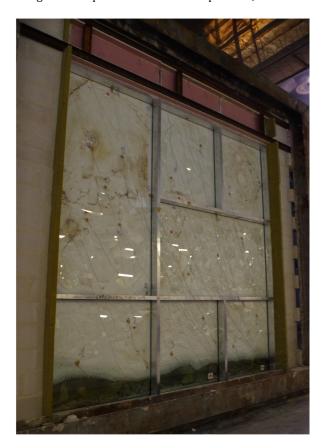
Fig. 25. Unexposed side of the test specimen after the test

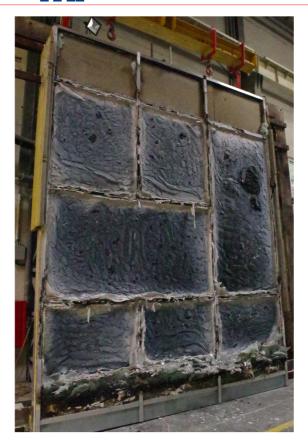
Fig. 26. Exposed side of the test specimen after the test

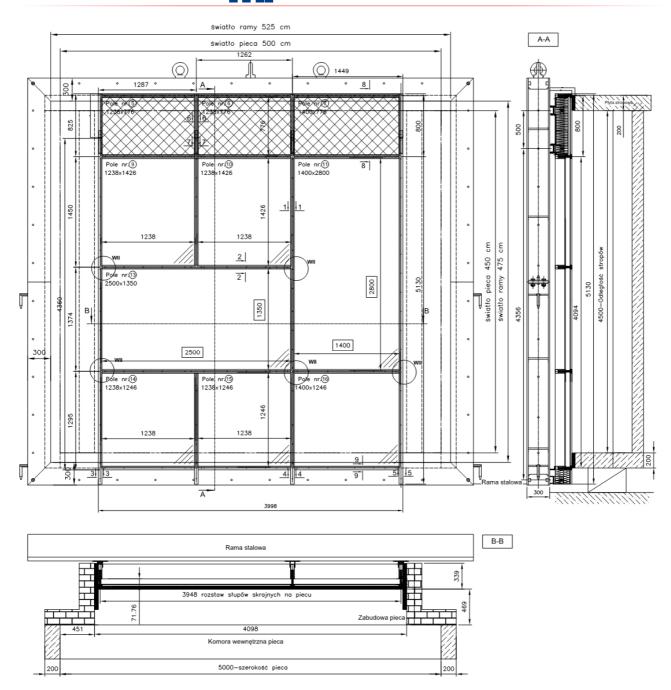
Fig. 1A. General view of the test piece, dimensions, section designation

- 4522x 5667 mm (total dimentions),
- 3998 x 4500 mm (test specimen heated dimentions),
- 4500 mm (span length between slabs).

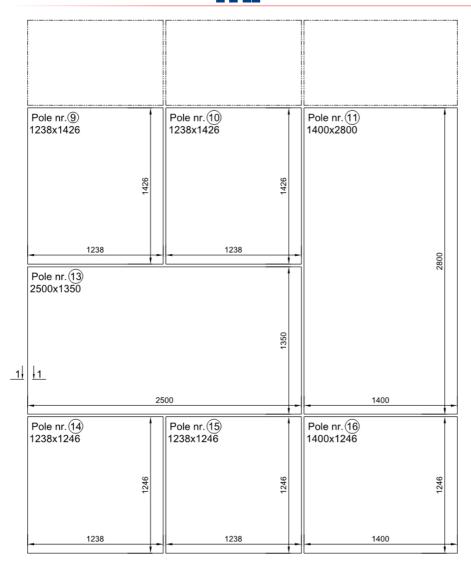
Fig. 2A. Transparent fillings

- Pyrobel 16 EI30 TGU glazing units with thickness of 61,1 mm (D)/ 61,1 62,3 (M) mm with following structure (listed form the outside): VSG 44.2 mm / spacer frame 14 mm/ ESG 6 mm / spacer frame 16 mm / Pyrobel 16 EI30 manufactured by AGC with thickness 17,3 mm. The details of the glass dimensions and placement are shown in fig. 2A in Appendix A.
- in area of the inter-stoyer belt, panels with following structure: glazing unit: ESG 6 mm/ spacer frame 16 mm/ ESG 6 mm; 100 mm + 40 mm rock wool with density of 80 kg/m³ type WENTIROCK manufactured by ROCKWOOL/ 0,80 mm steel sheet / 12,5 mm type F plasterboard.

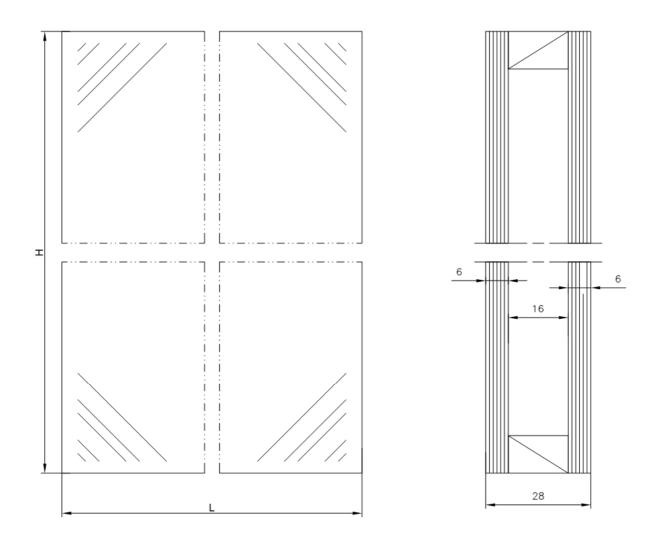
Zestawienie wymiarów szyb do badań modelu ściany osłonowej MB-SR50N EI30 od strony zewnętrznej. Szyba jednokomorowa hartowana 2x6mm

Nr. pola	wymiar LxHxG [mm]	szt.
5,6	1238 x 776 x 28	2
7	1500 x 776 x 28	1

Fig. 3A. Glass panes in non transparent fillings

- glazed unit: 6 mm ESG glass / 16 mm spacer frame / 6 mm ESG glass;
- 100 mm rock wool (with additional layer of 40 mm in the level of the slab) with density of 80 kg/m³, Wentirock type manufactured by Rockwool

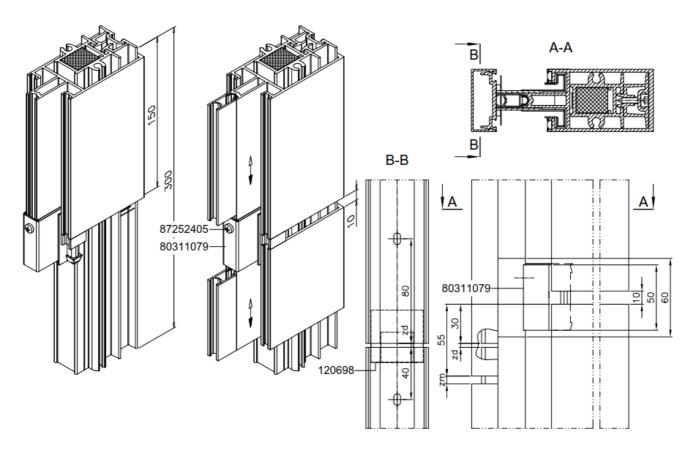
Fig. 15A. Scheme for making an expansion joint

Load-bearing mullions were interrupted in the floor level with 10 mm dilatation allowing mullion expanding. The dilatation was made with system aluminium profile (cat. No. K432144X and K432146X),

which was filled and cladded with type Promatect H insulation boards and spaced by insulators cat. No. 009020.

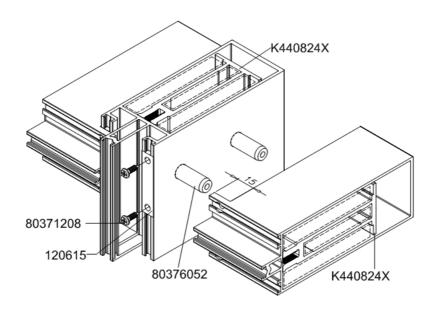
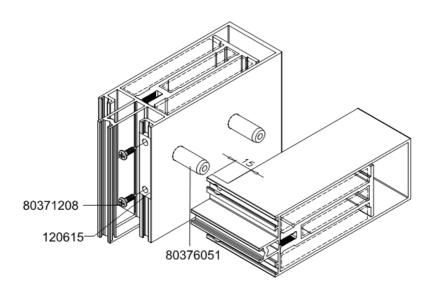
Fig 16A. Schemes of making transom - mullion connections

The reinforcement inserts were connected to mullions and transoms with steel connectors cat. No. 80312107 (transom) and 80312108 (mullion). The mullions and transoms were connected with overlap and by additional steel connectors cat. No. 80376051 and 80376052 (one-sided and double-sided respectively) mounted to mullions on which transoms were shoved.

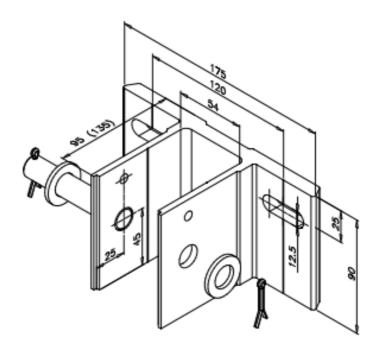
Rys. 17A. Fixed bracket cat. No. $\,80002127$

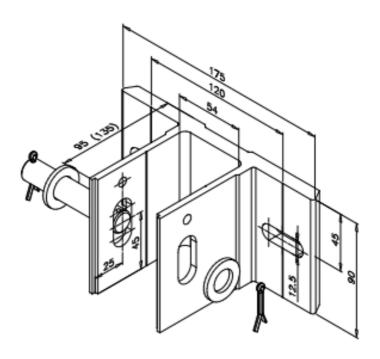
Rys. 18A. Sliding bracket cat. No. 80002128

The connection of the curtain wall of the MB-SR50N EI type EI30 system with the steel frame was made by means of aluminum sliding brackets 1D (135 mm) cat. No. 80002128 thickness of 5.7 mm, connected to the mullions through steel sleeves with M12 x 95 mm screws. The aluminum brackets were connected to the steel C-section with M12 x 45 mm steel bolts, washers and nuts.
