Instytut Techniki Budowlanej (ITB)

TESTS REPORT LZP01-01036/23/R742NZP/ENG

Curtain wall straight specimen in full configuration of
Aluprof MB-SR50N EI EI30 system, heating from the
inside

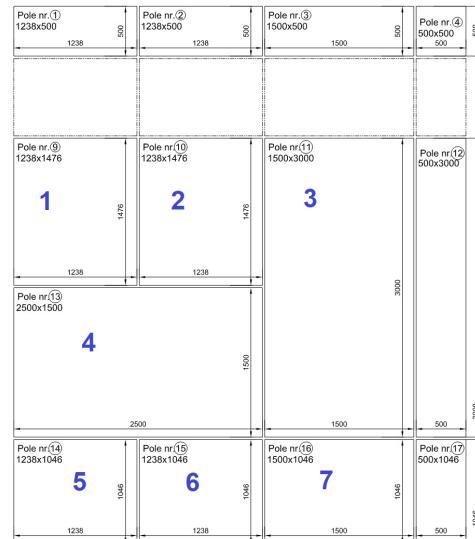
Thickness of fire-resistant glazed units (average of 4 measurements)

Glass nr 1	61,41
Glass nr 2	61,25
Glass nr 3	62,17
Glass nr 4	61,21
Glass nr 5	61,25
Glass nr 6	61,42
Glass nr 7	61,41

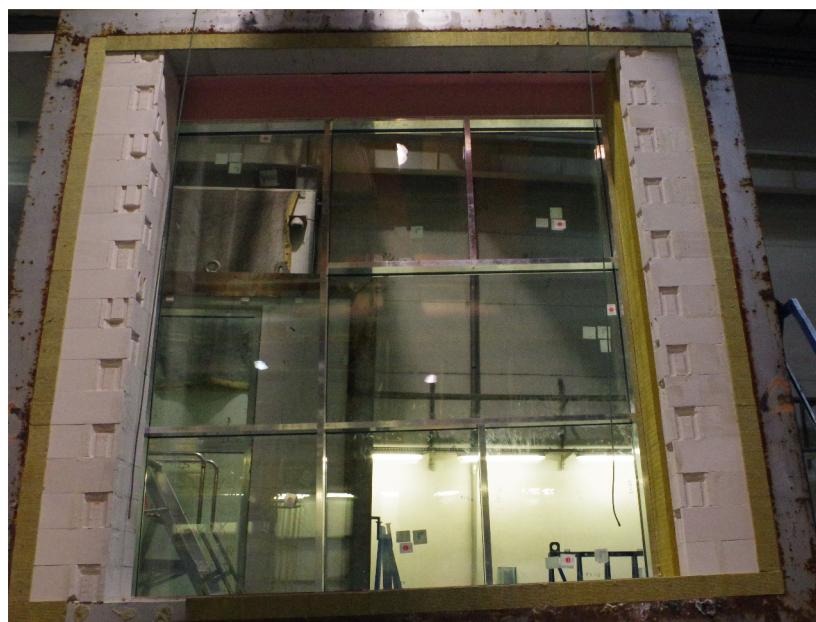
Fig. 1. Test specimen before the test – exposed side (before facing the furnace)

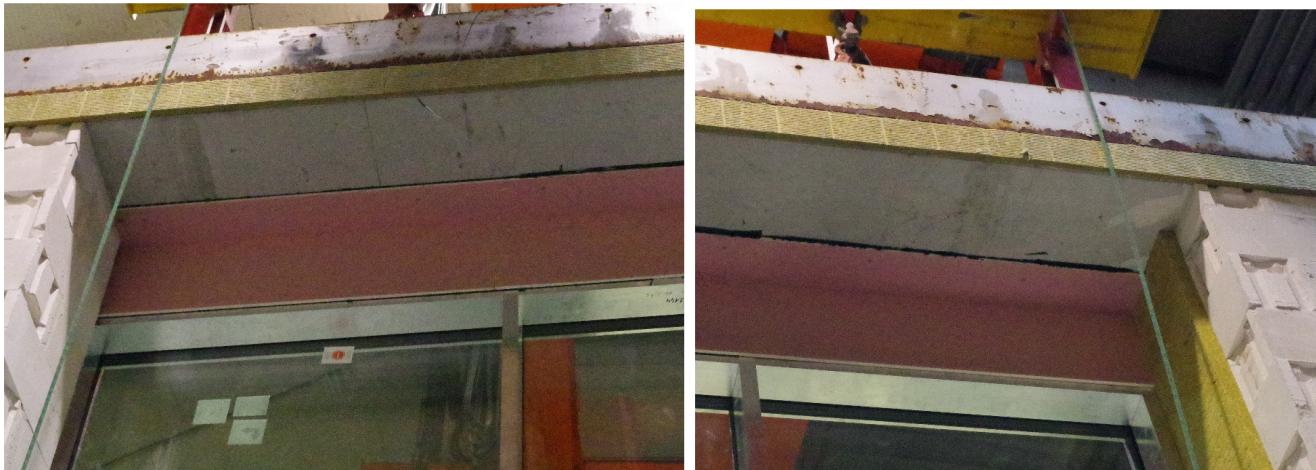
Fig. 2. Test specimen before the test - unexposed side, details

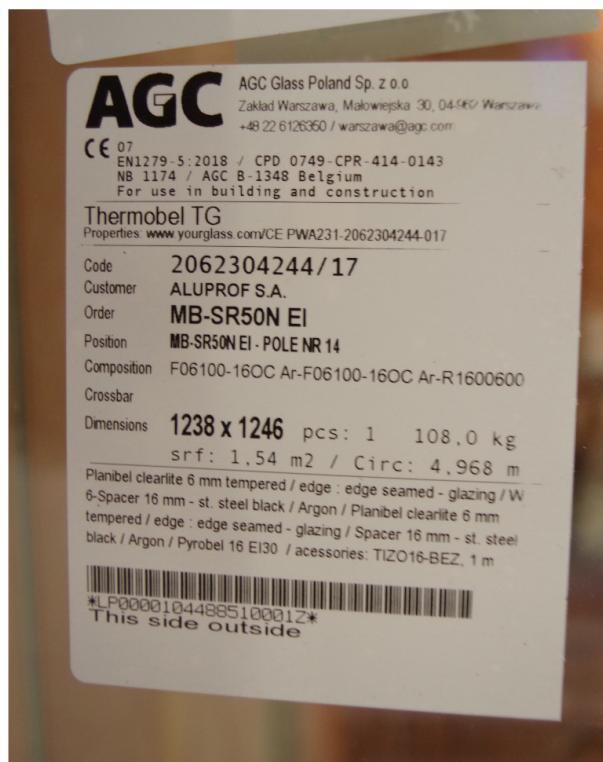
Fig. 3. Test specimen before the test during the montage - details

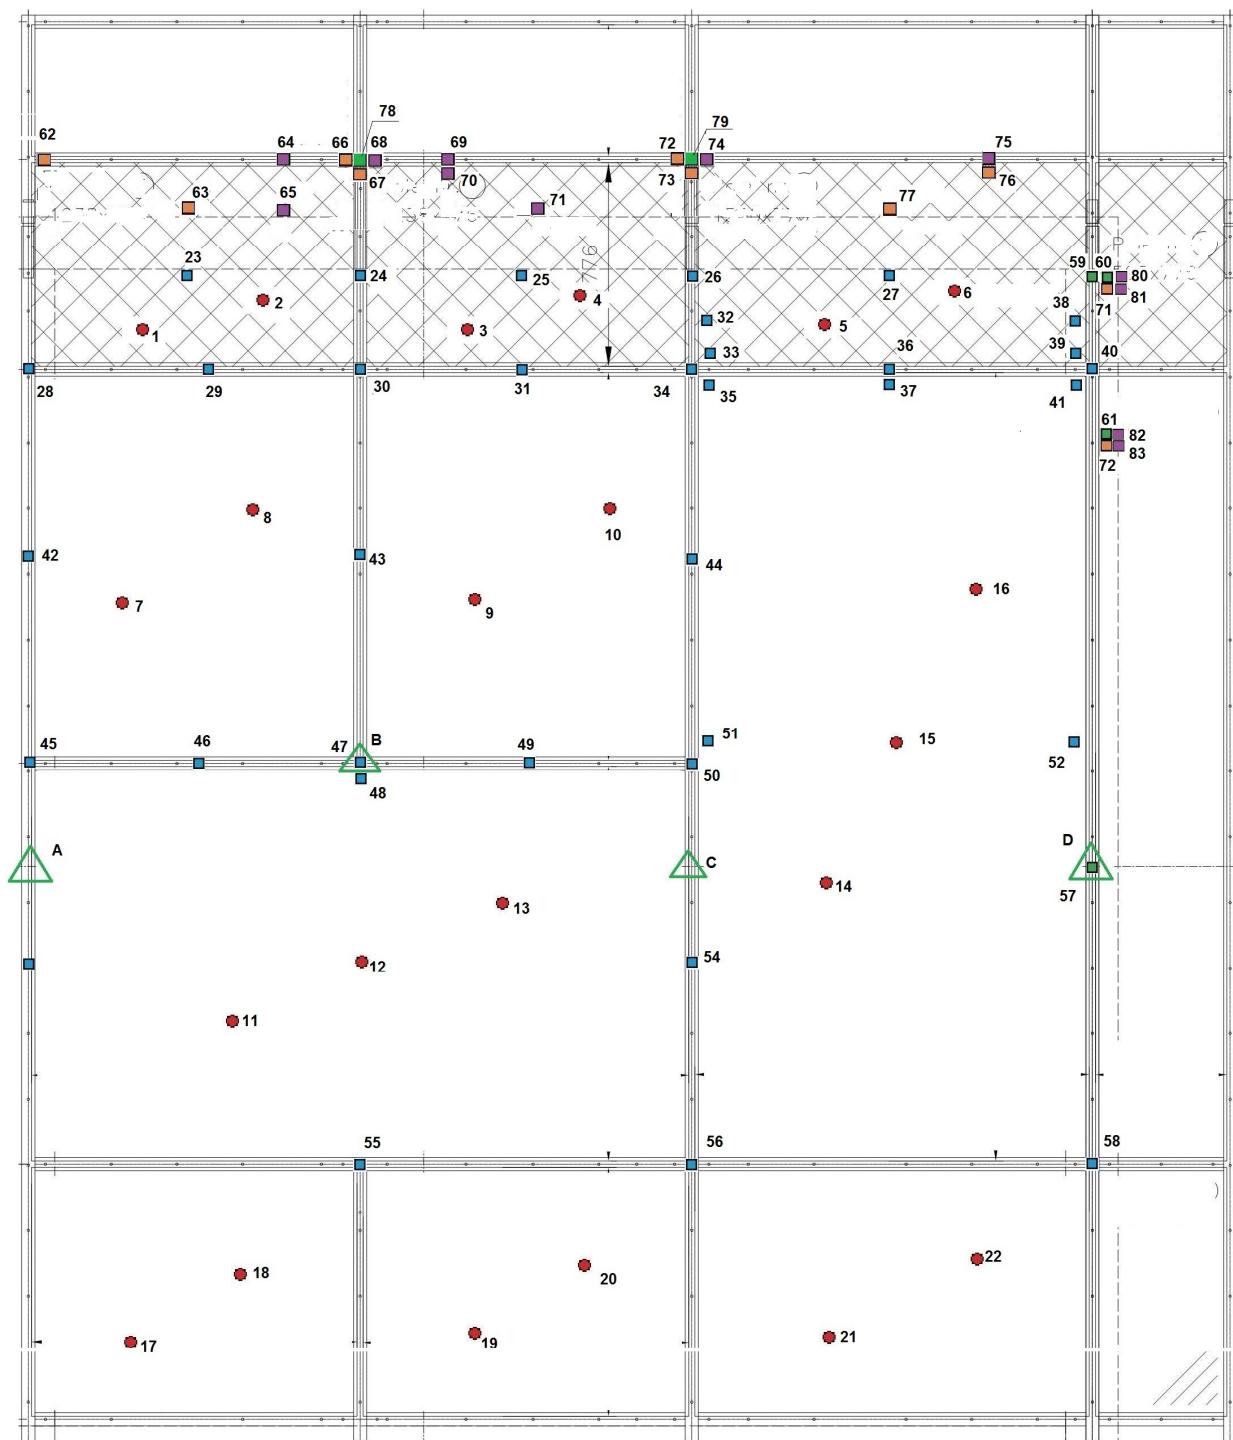
- thermocouples for average and maximum temperature rise measurements on surface 2
- thermocouples for maximum temperature rise measurements on surface 2 and 6
- thermocouples for maximum temperature rise measurements on perimeter seal
- thermocouples for maximum temperature rise measurements on surface 3 and 4
- thermocouples for maximum temperature rise measurements on fixing elements (anchors)
- △ - deflection gauges

Fig. 4. Location of measurement points on unexposed side of the test specimen

Location of measurement points: Fig. 4

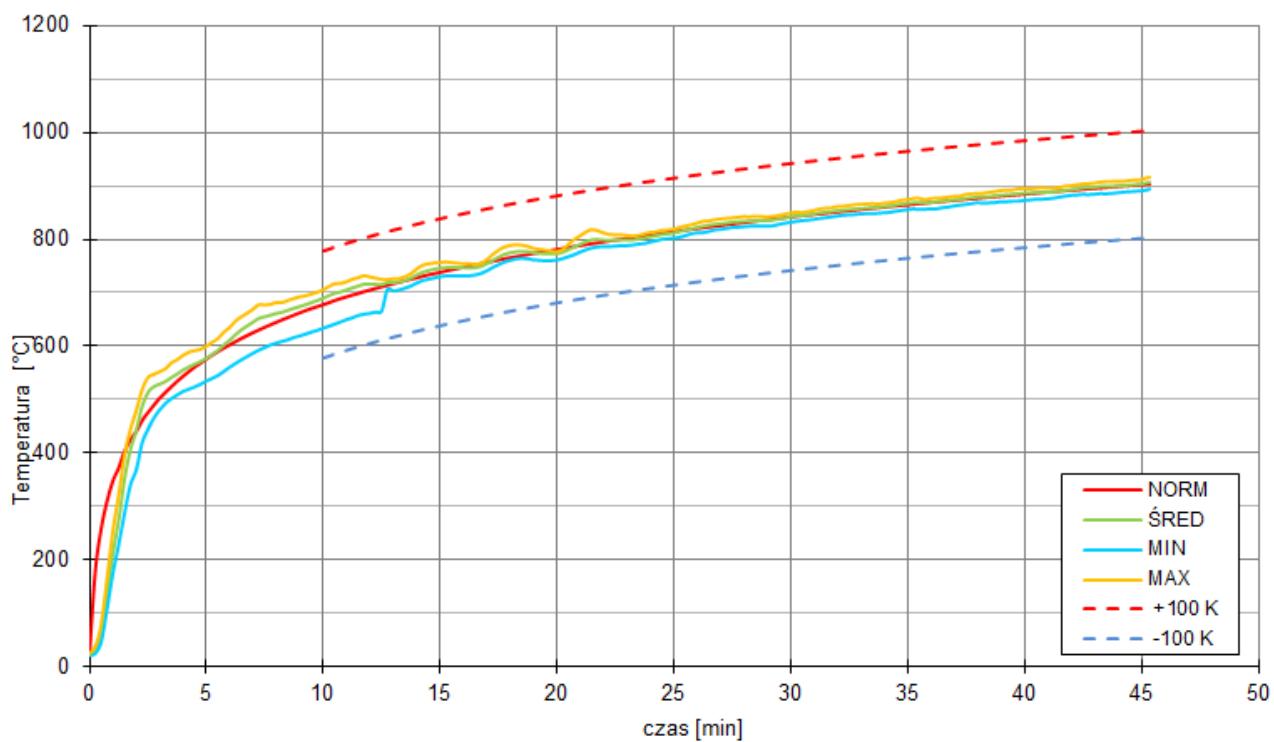
Fig. 5. Temperature of furnace heating conditions

Initial temperatures: fig. 5, standard curve

furnace: 19,9°C, ($19,9^{\circ}\text{C} \leq 50^{\circ}\text{C}$)

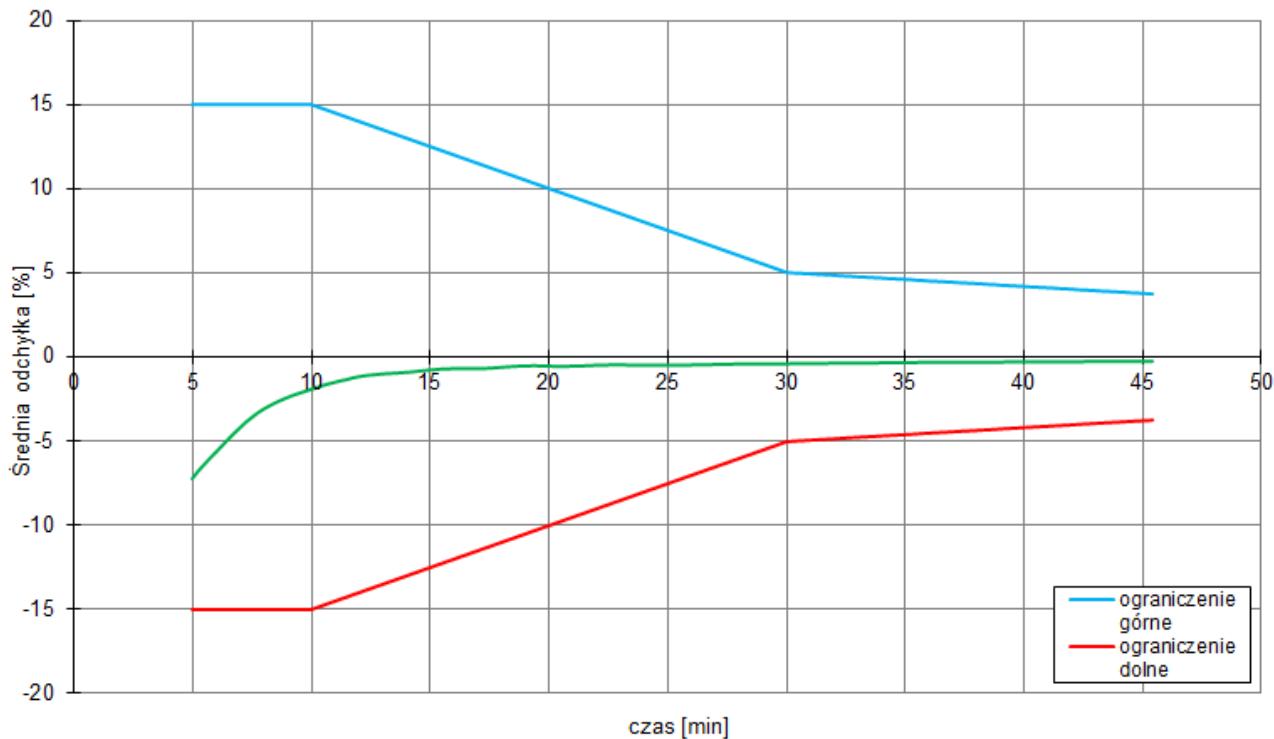
Fig. 6. Tolerance of heating

Heating tolerance: Fig. 6

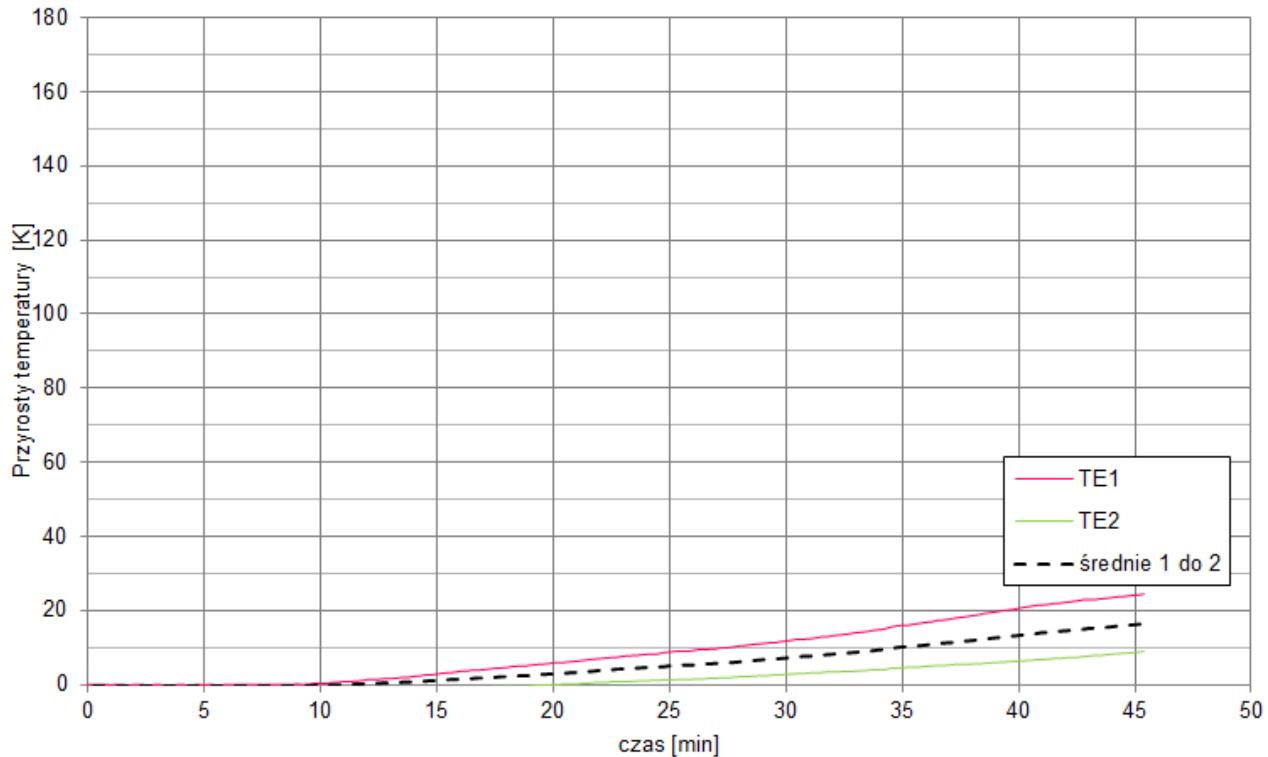
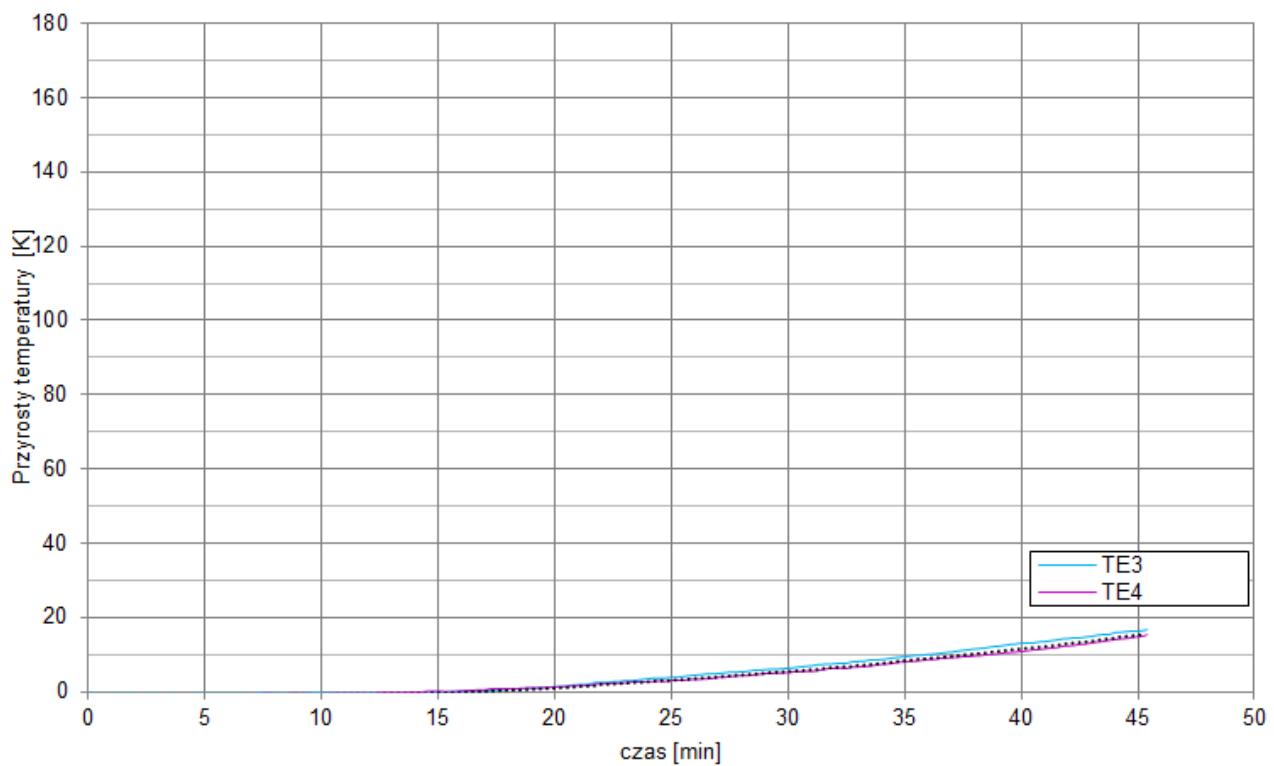
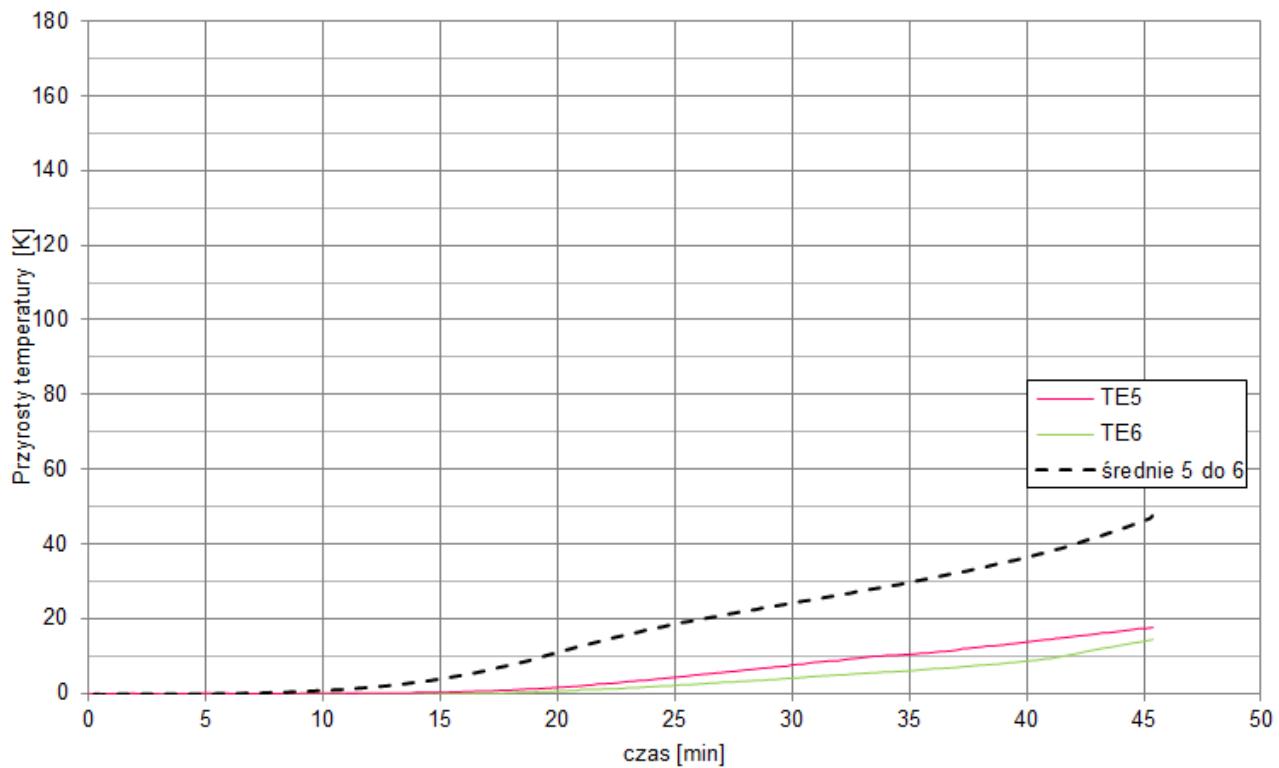
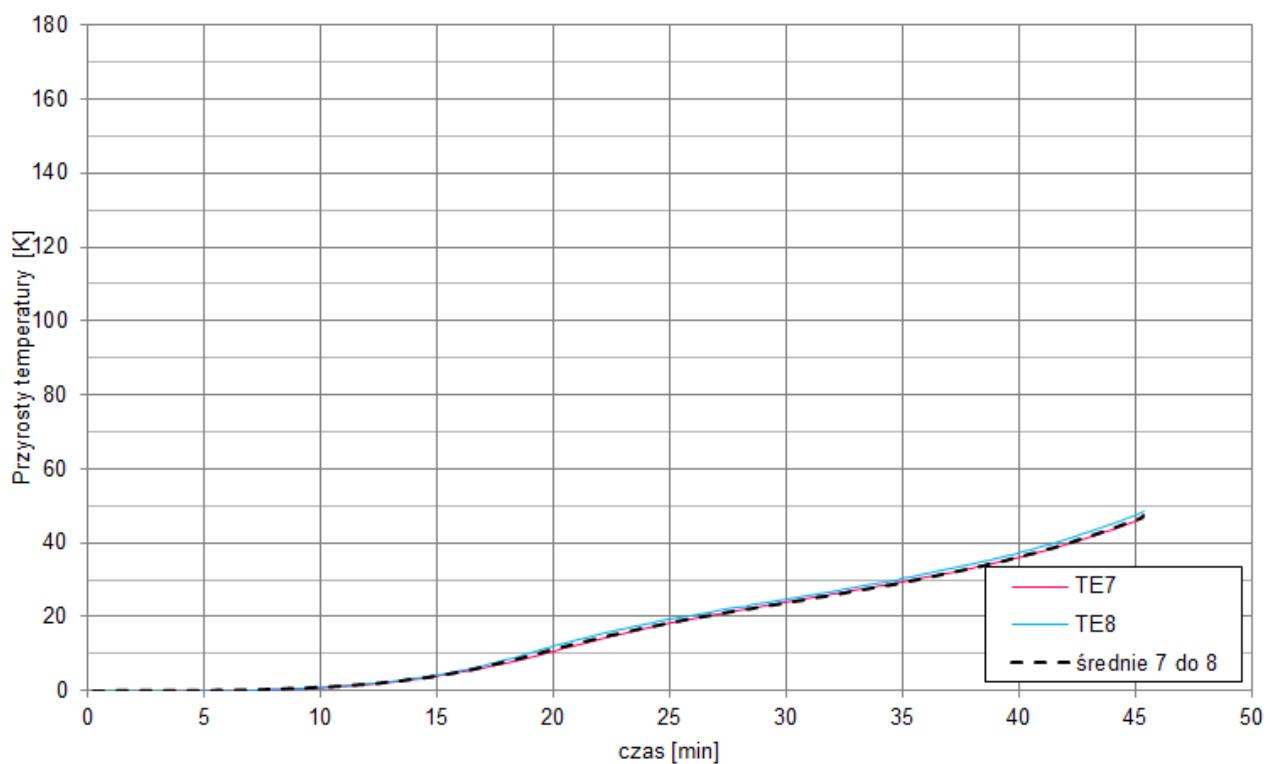
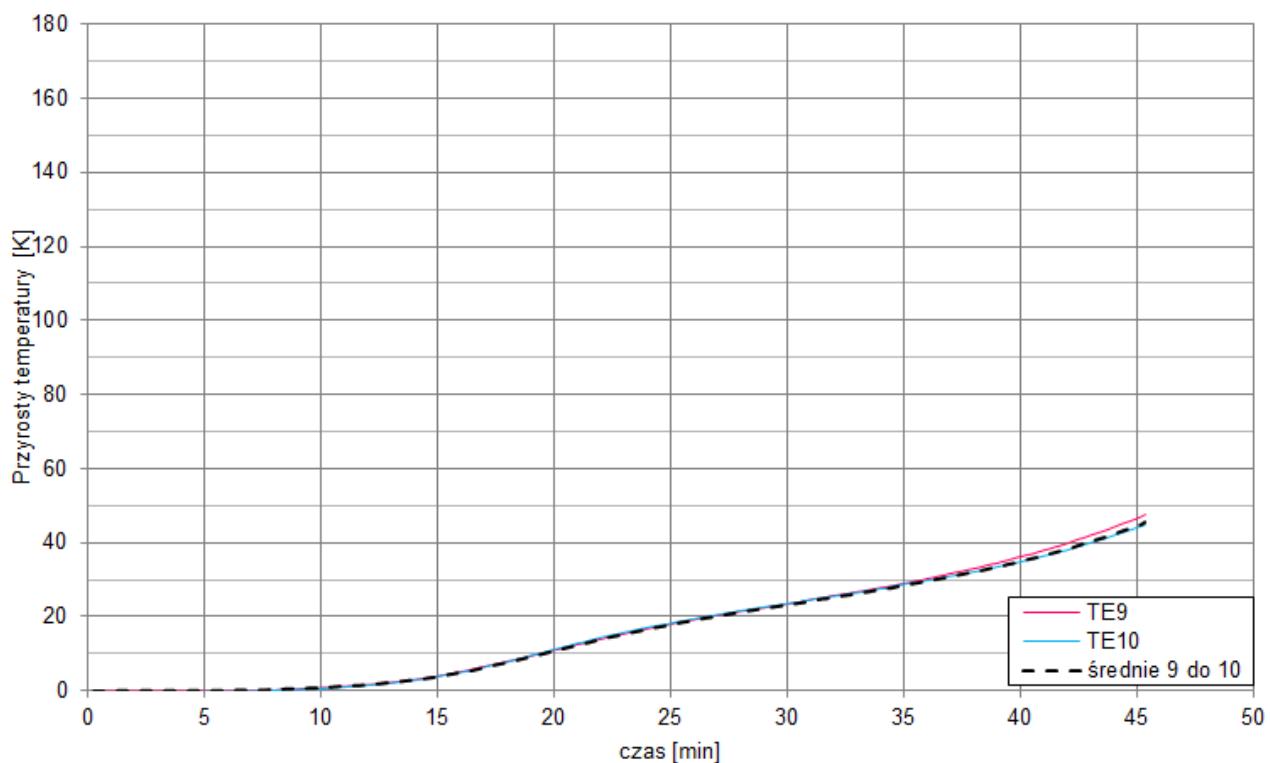
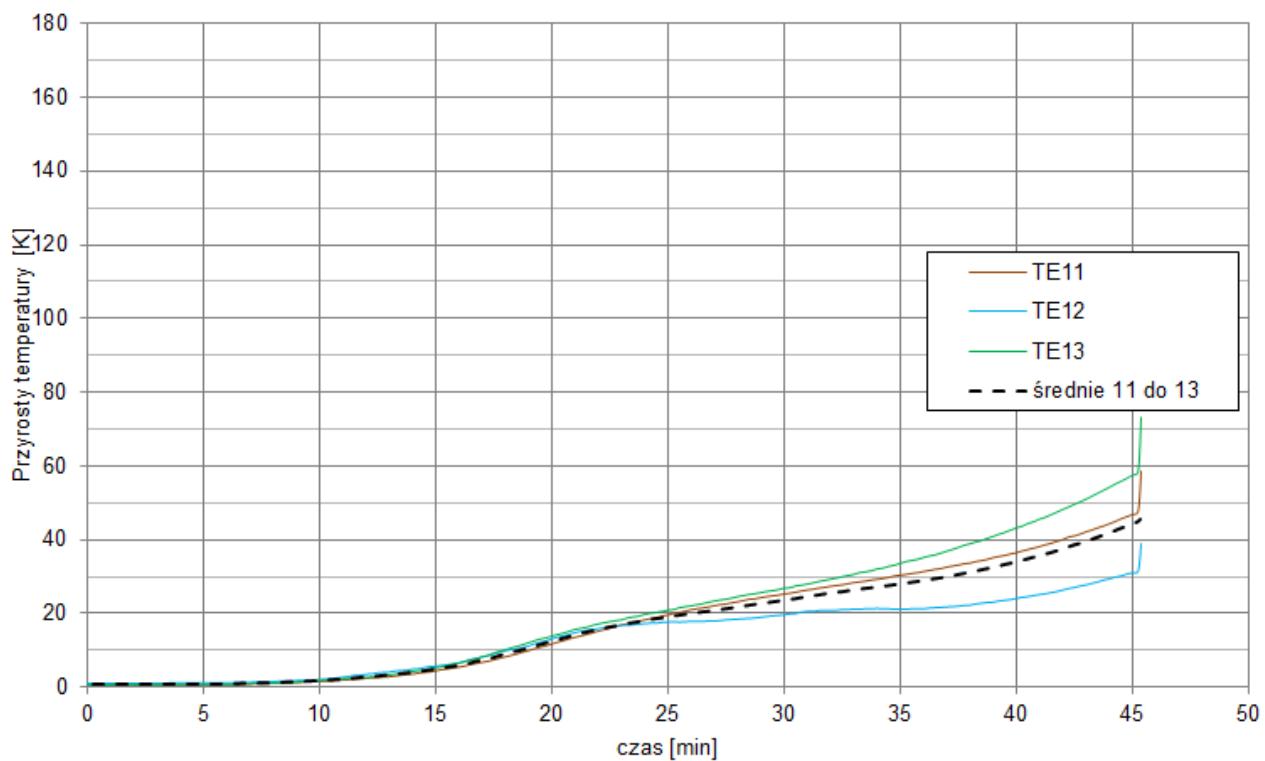
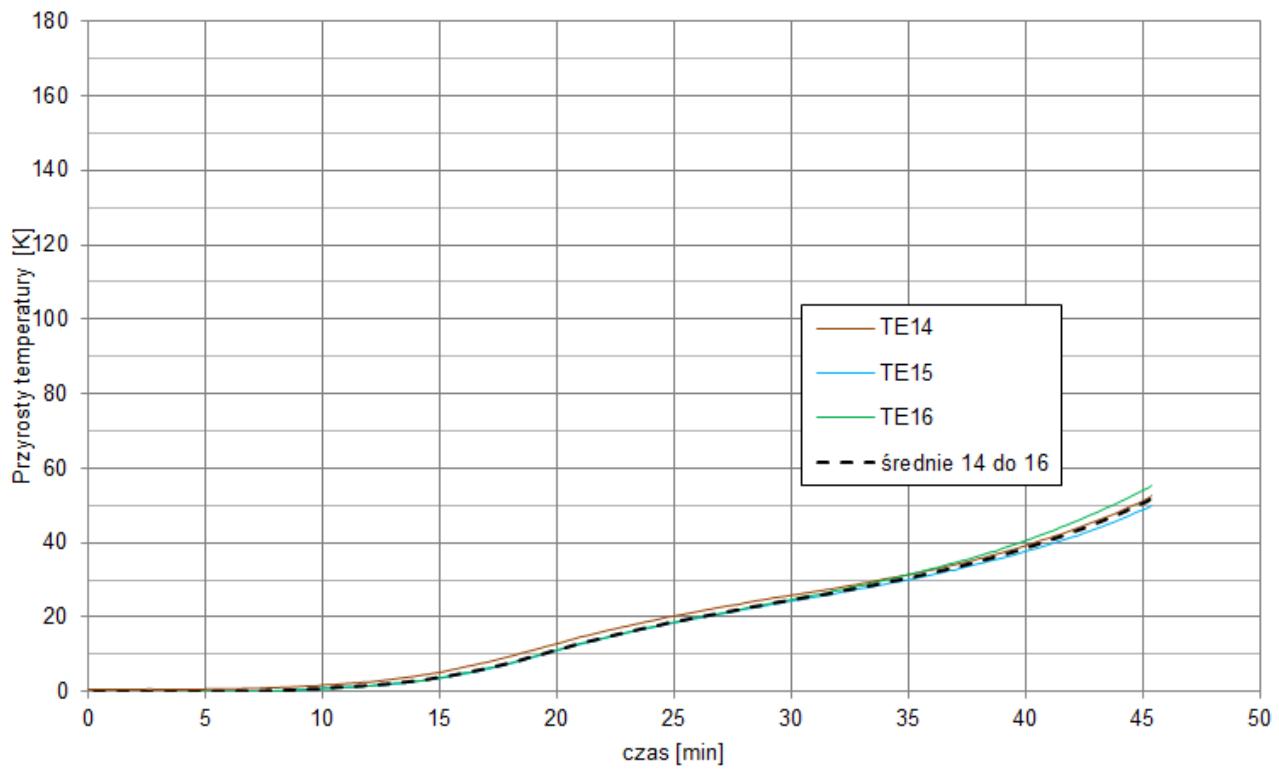
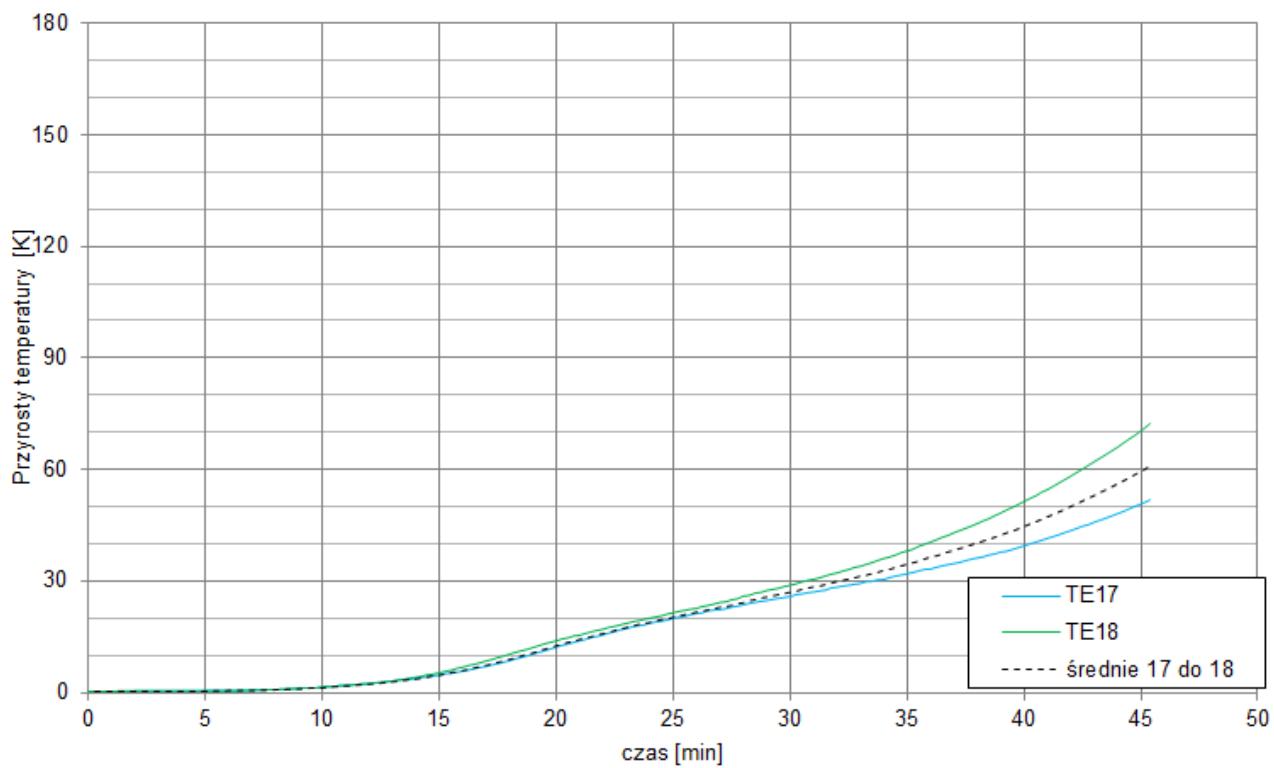
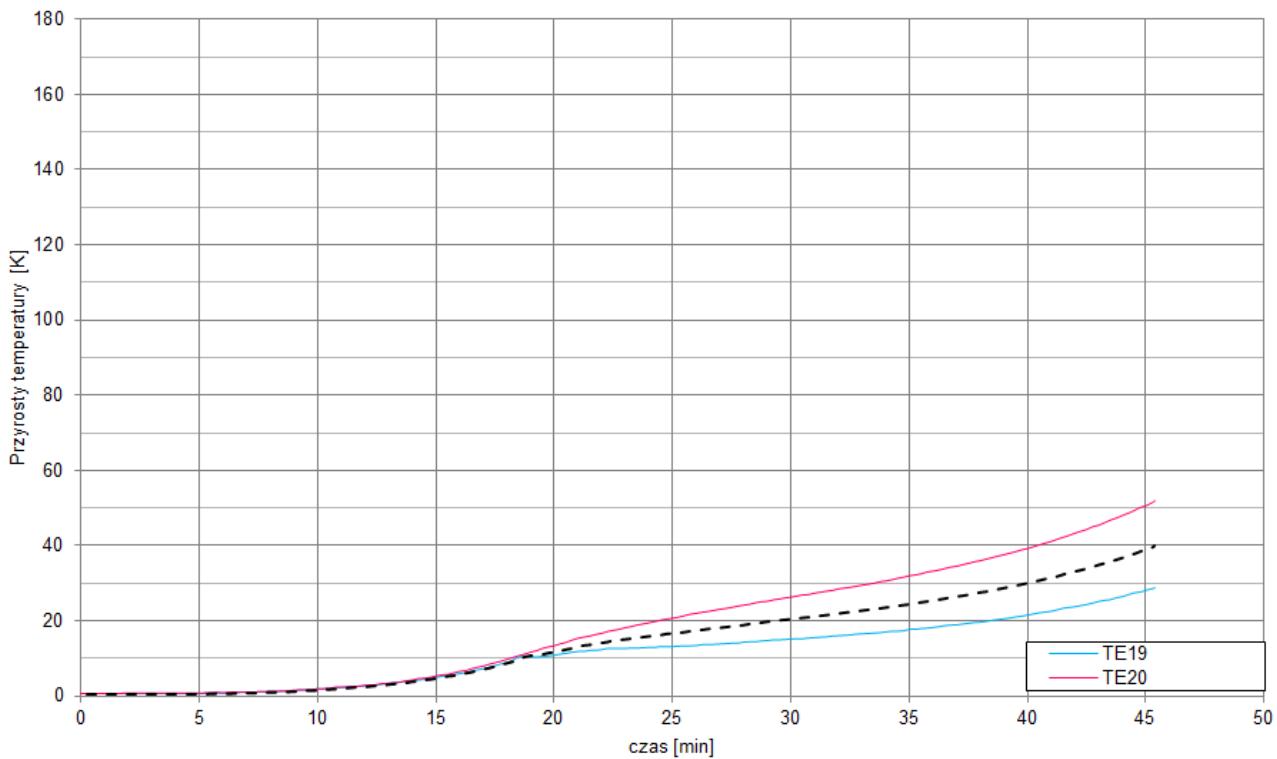
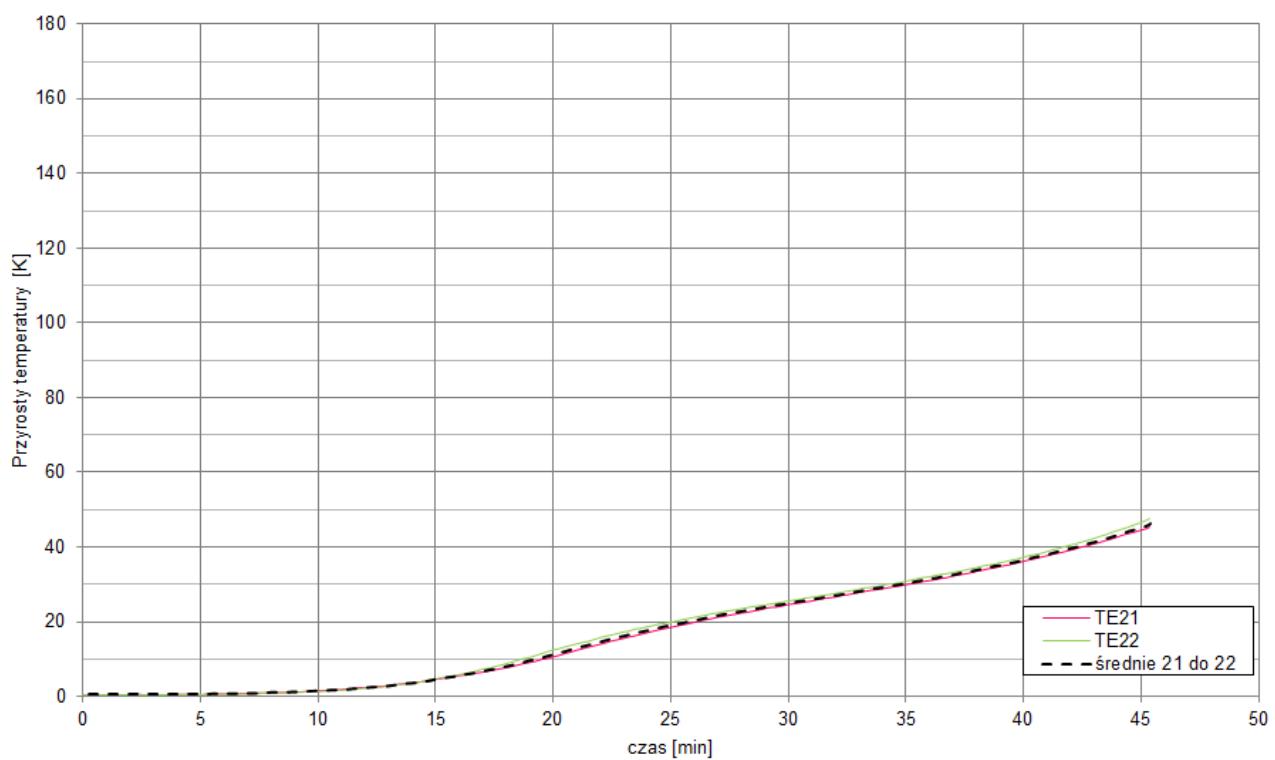
Fig. 9. Temperature rise on the unexposed surface of the test specimen – average and maximum temperature thermoelements

Temperature rised on the unexposed surface: Fig. 9 -30
