Instytut Techniki Budowlanej (ITB)

TESTS REPORT LZP01-01036/23/R742NZP/ENG

Curtain wall straight specimen in full configuration of
Aluprof MB-SR50N EI EI30 system, heating from the
inside

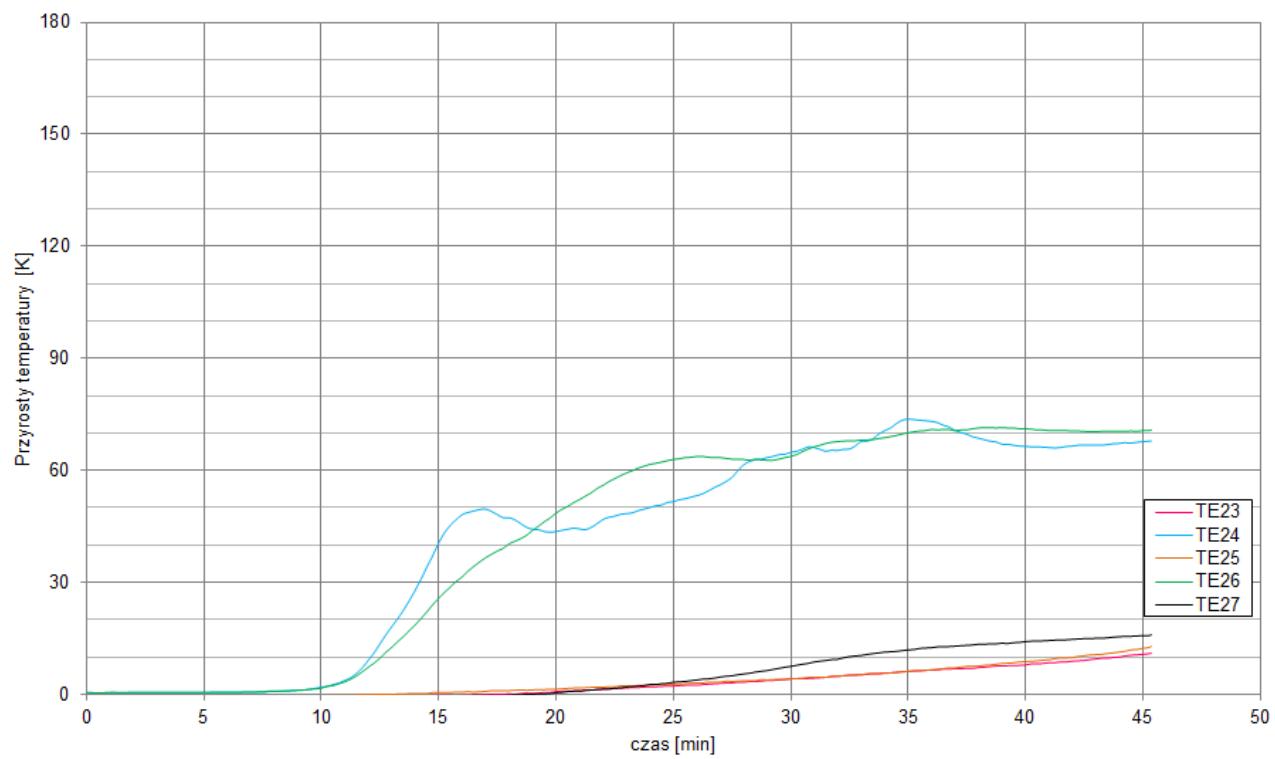
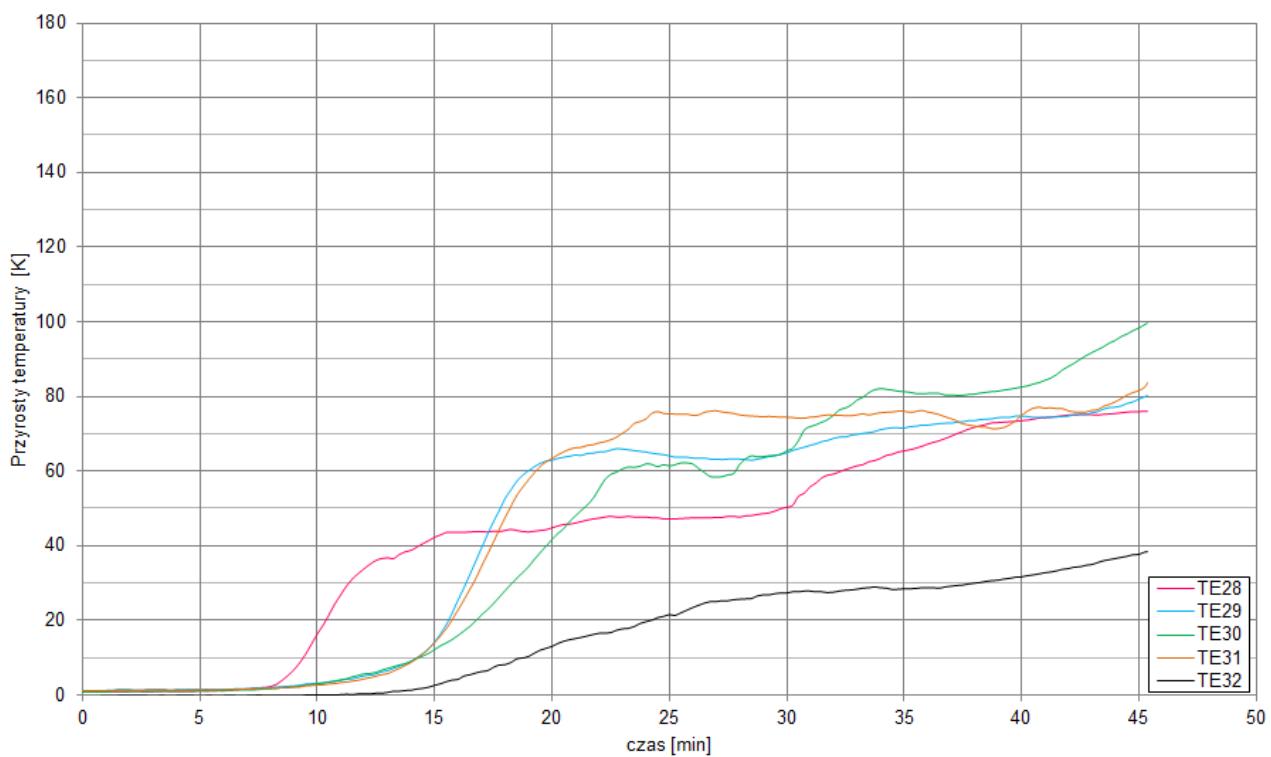
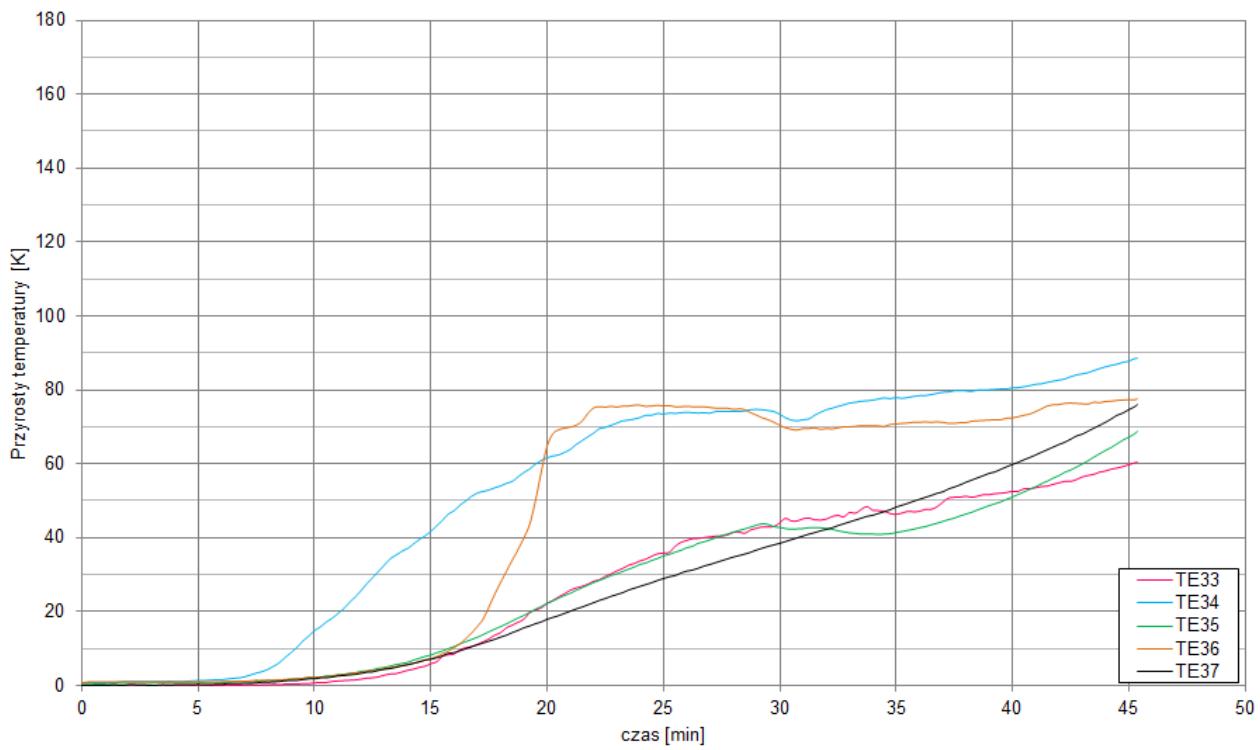
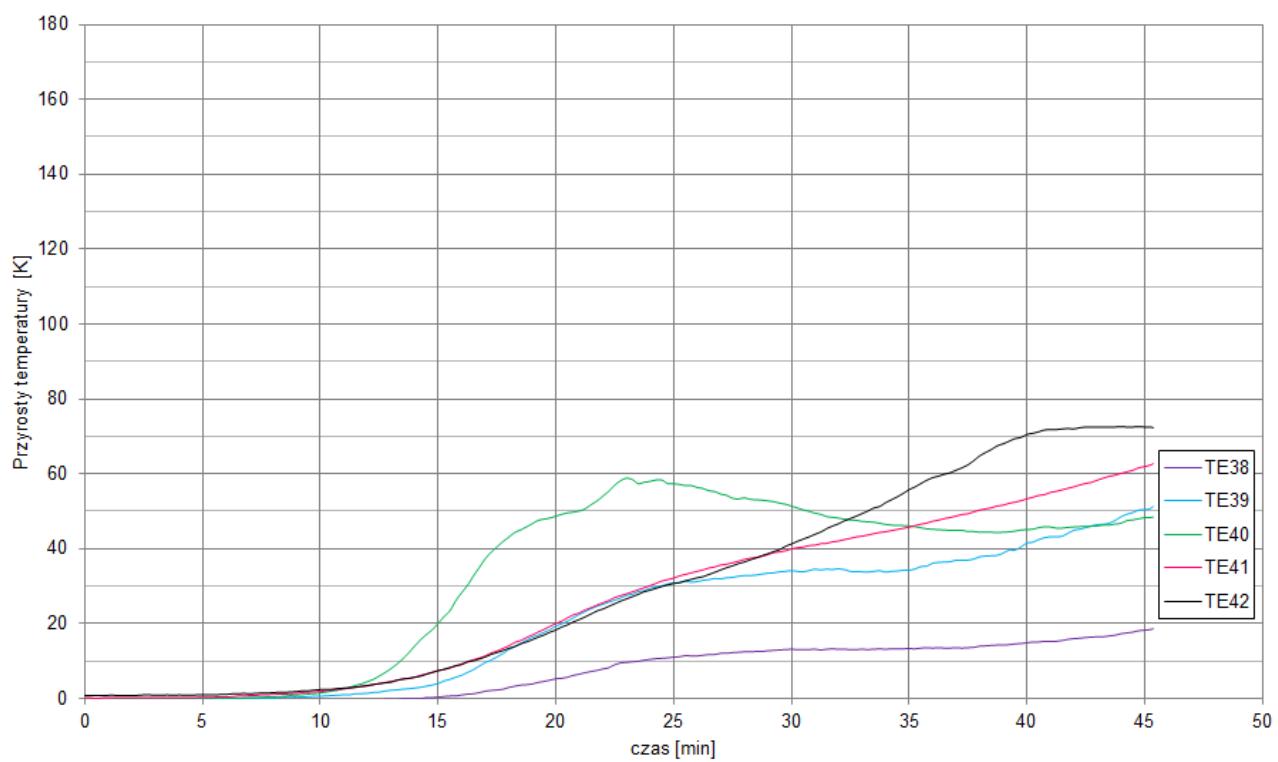
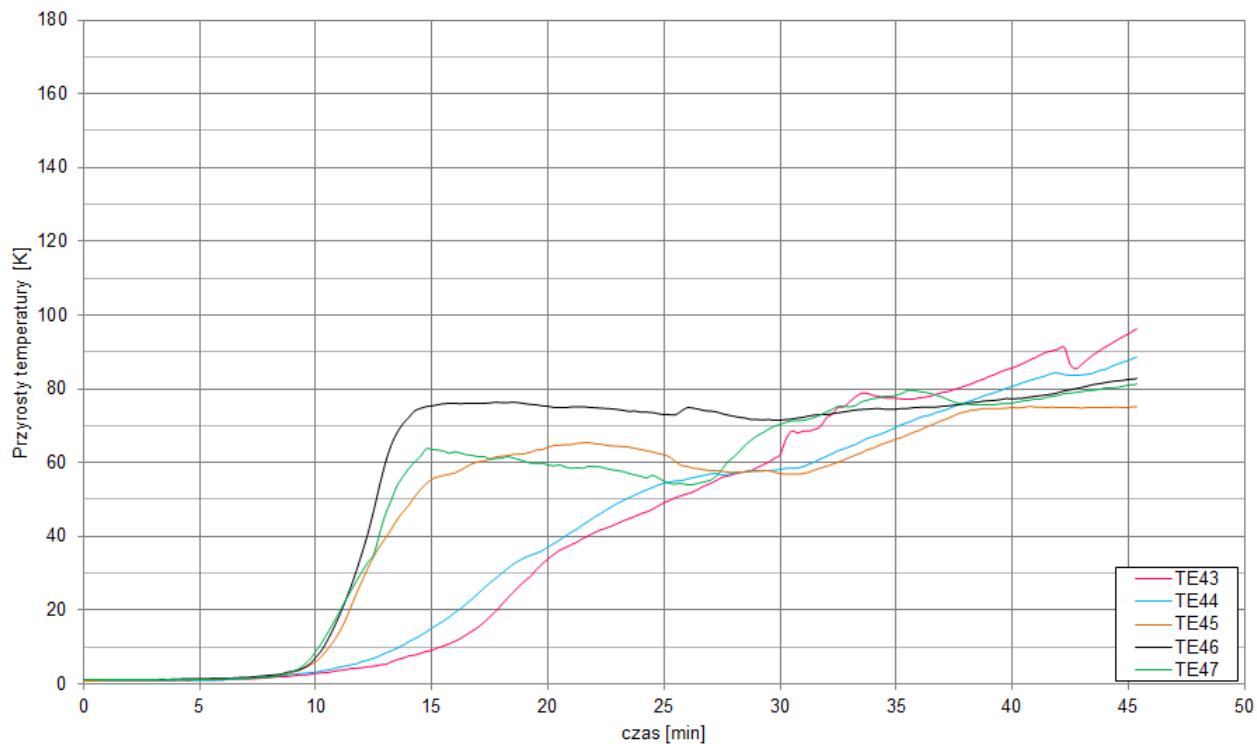
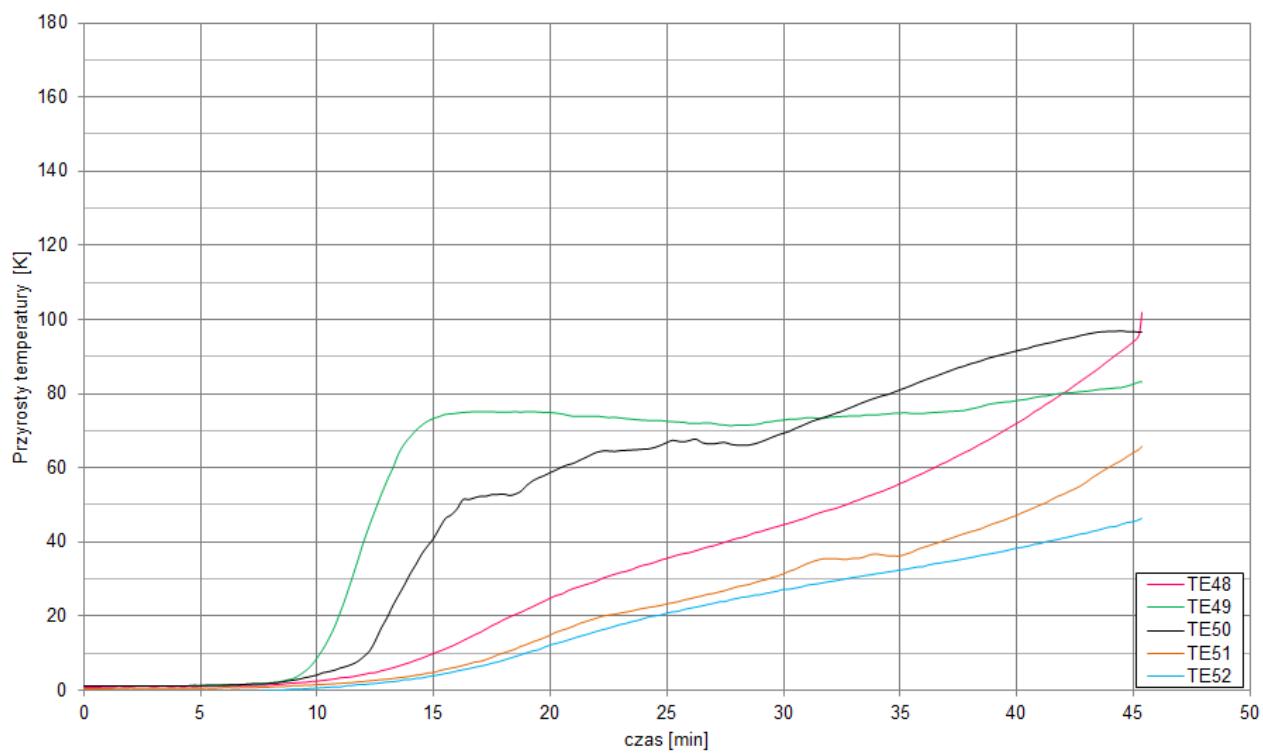
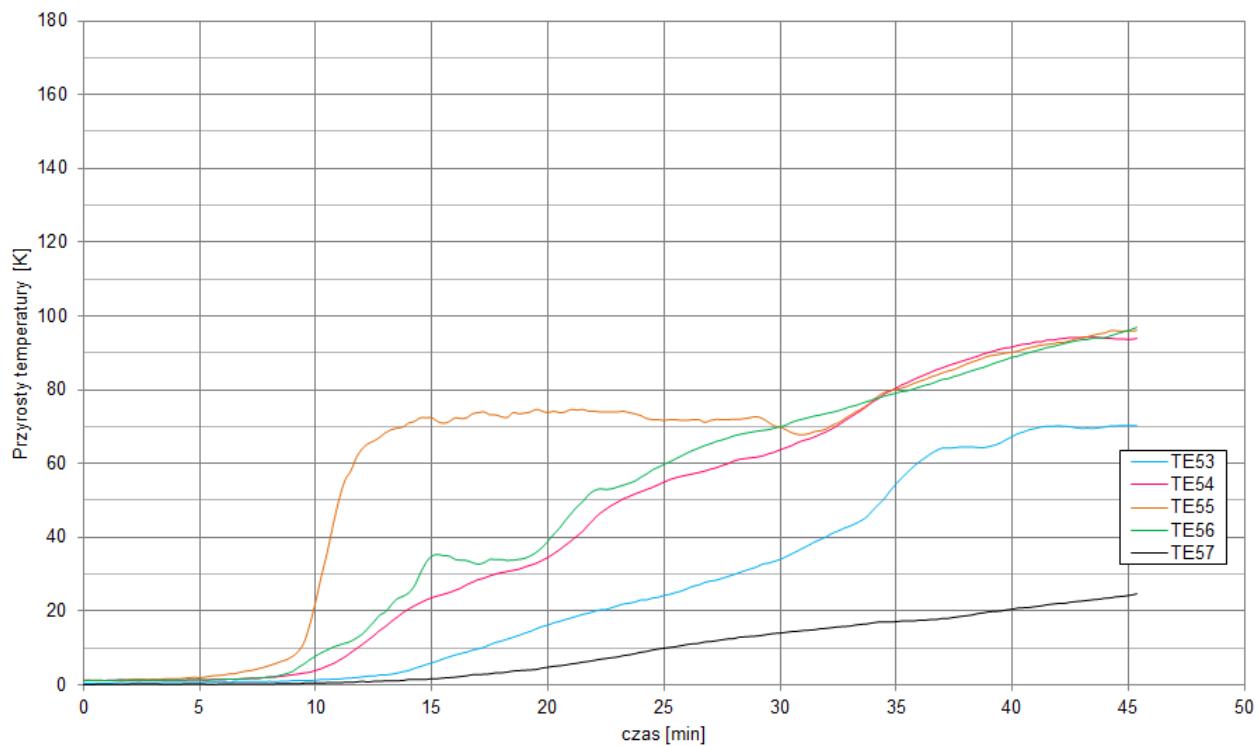
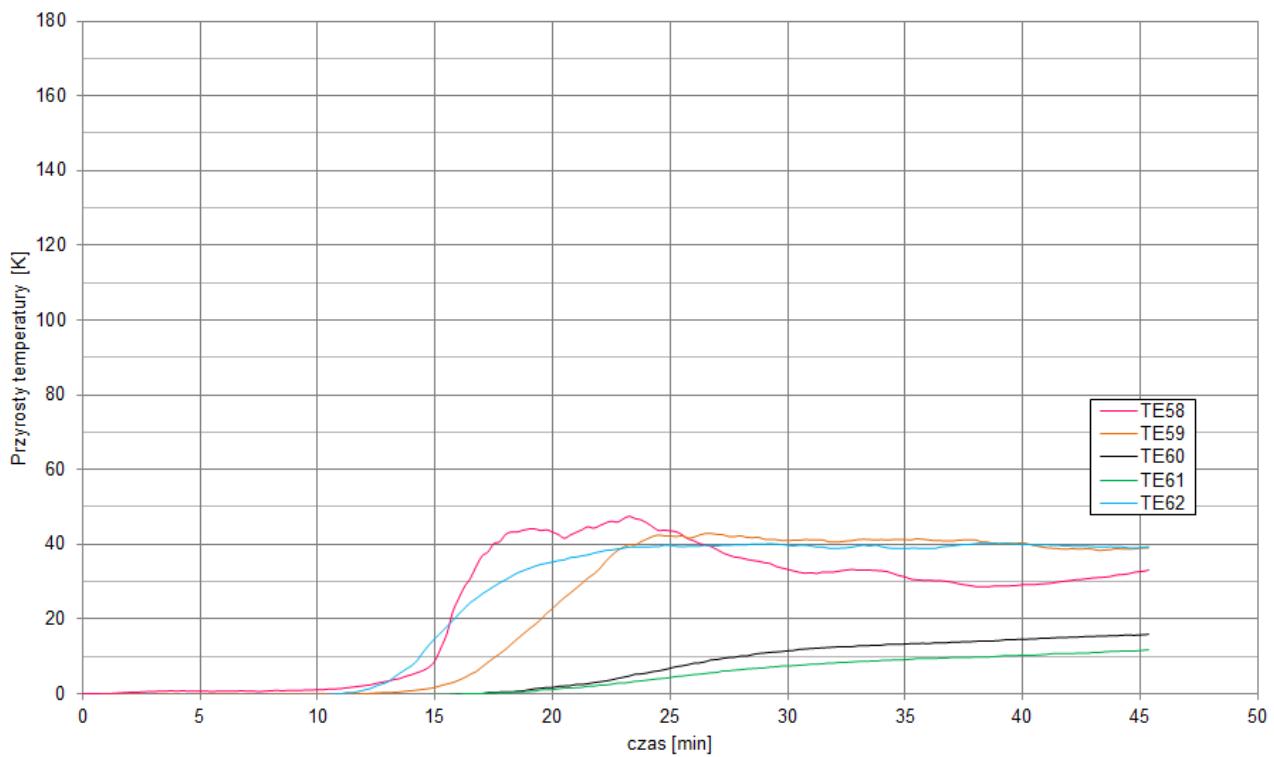
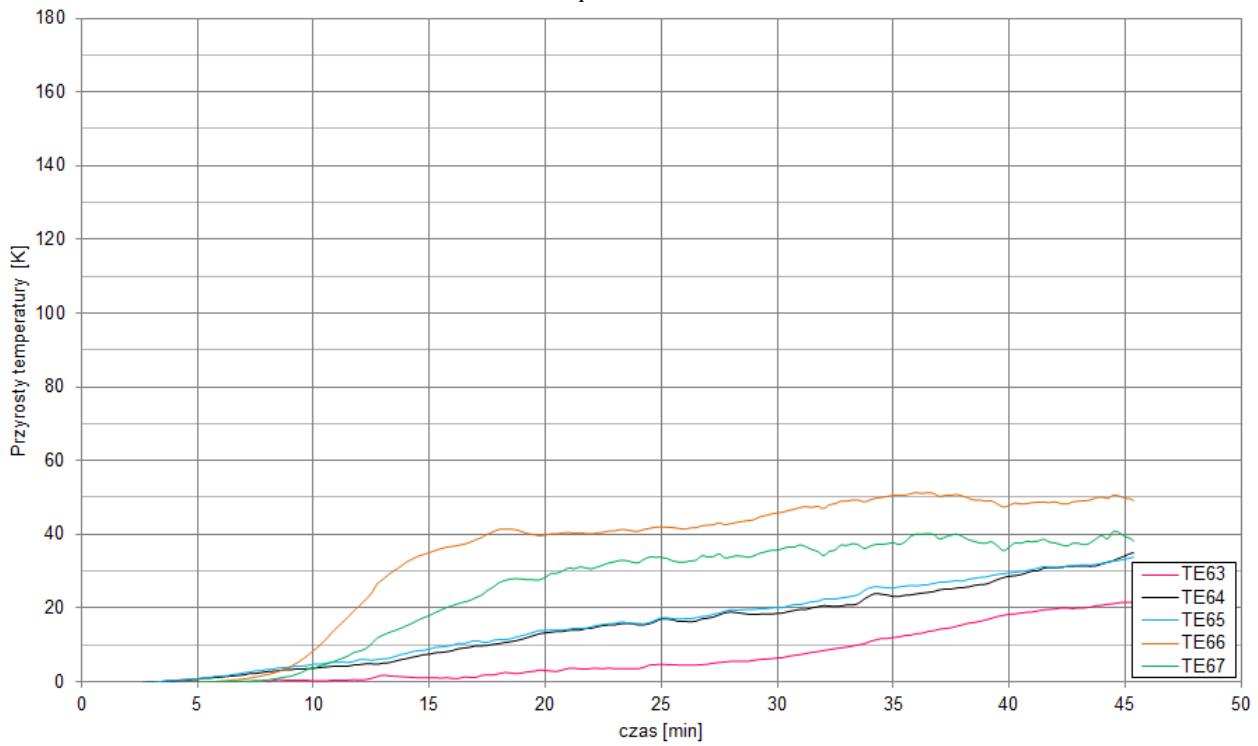
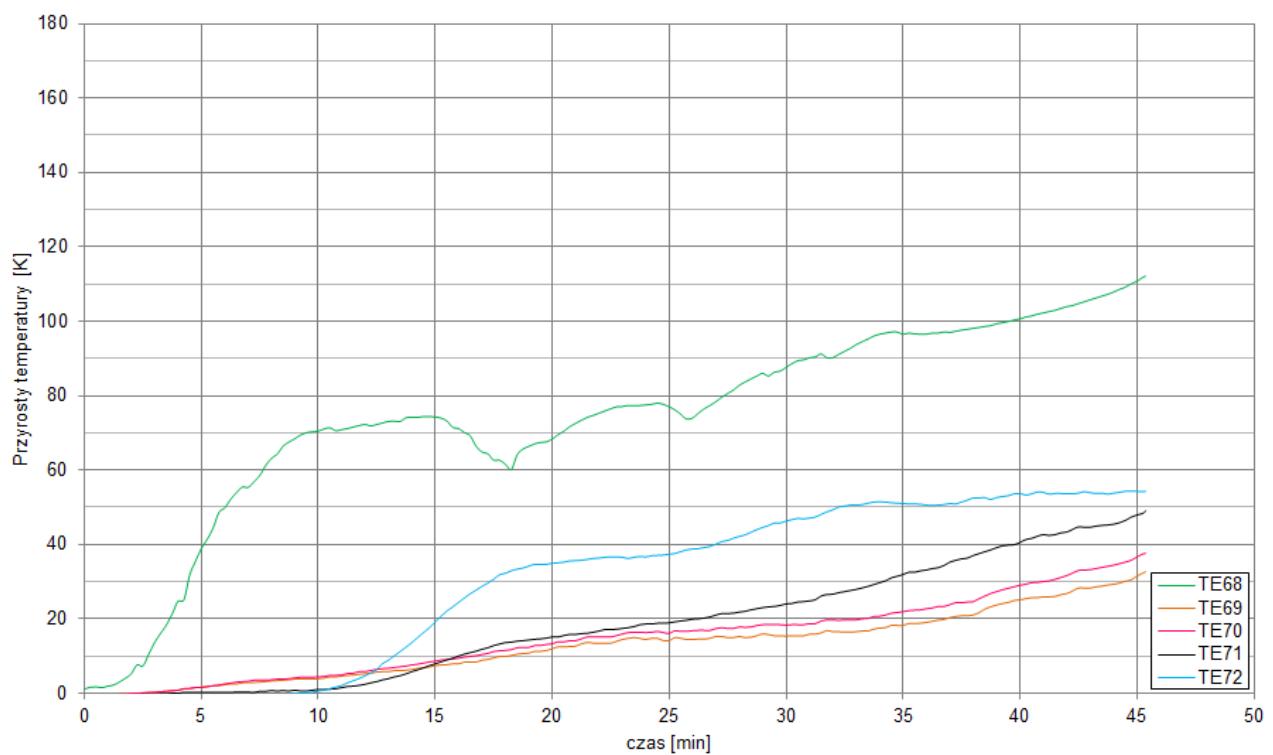
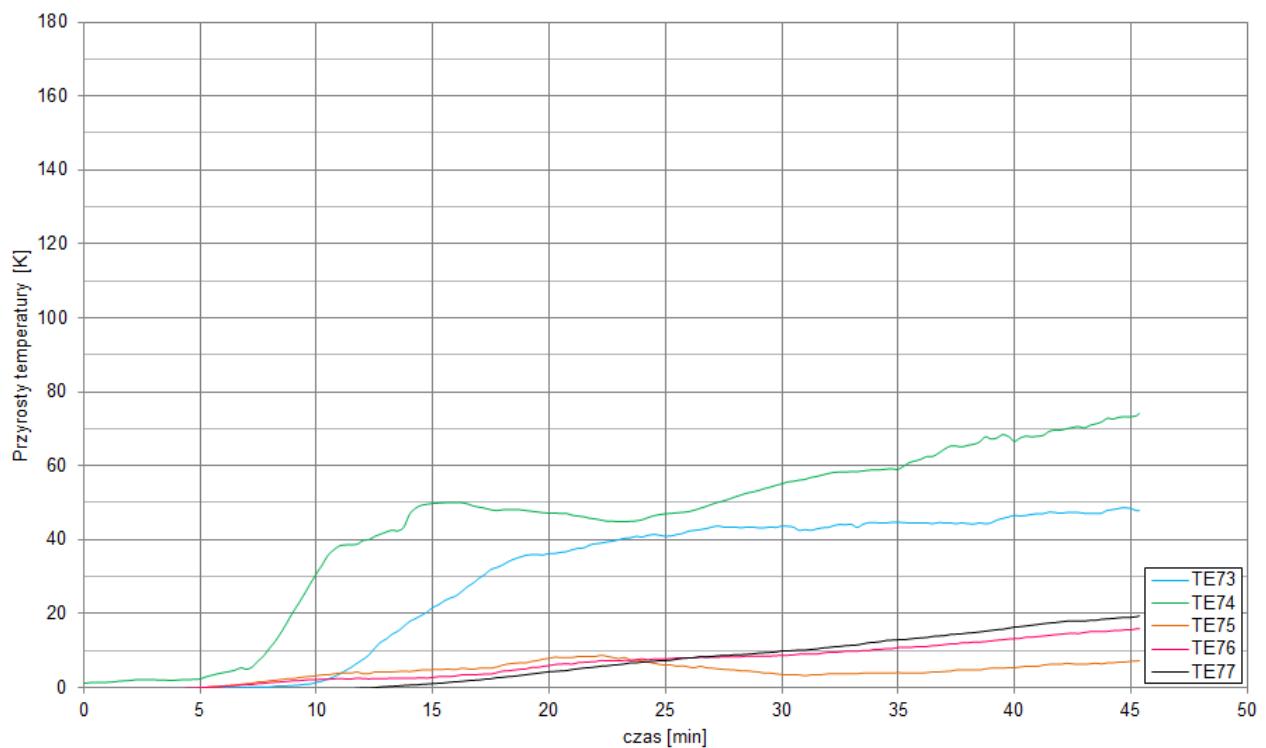
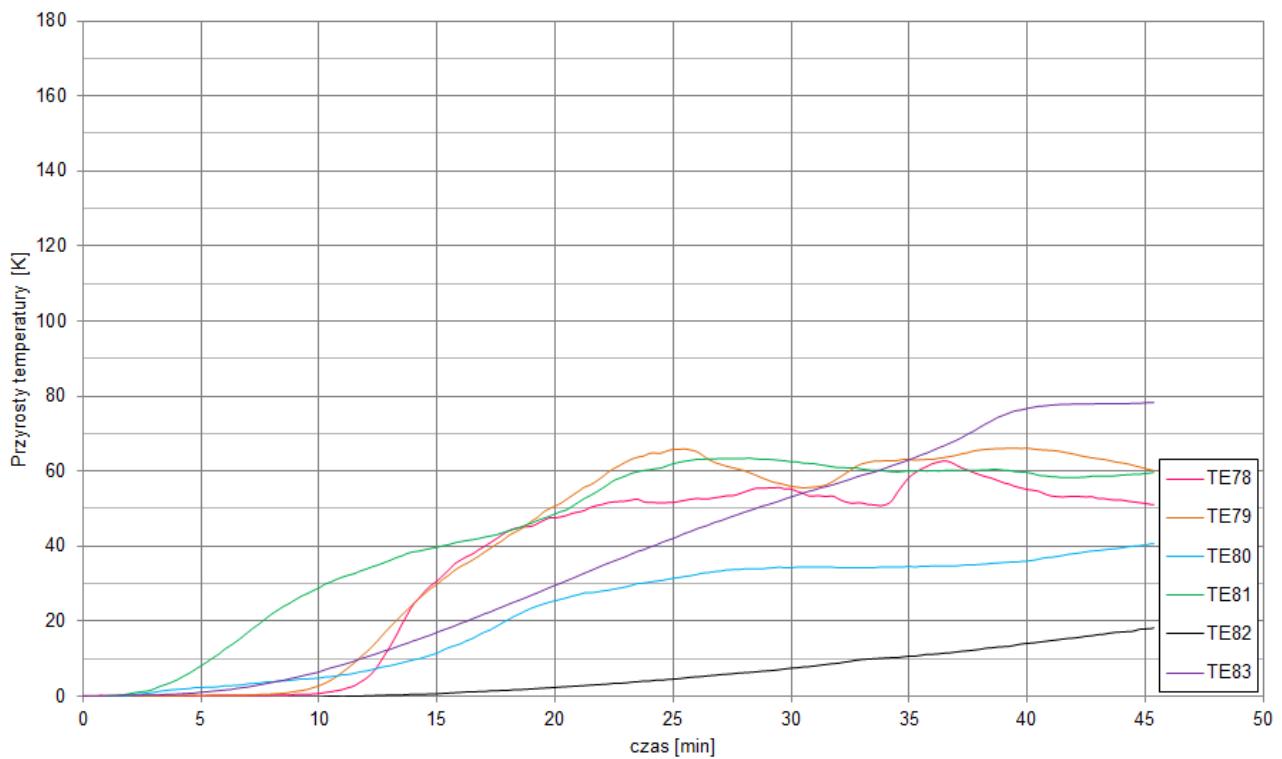
Fig. 19. Temperature rise on the unexposed surface of the test specimen – maximum temperature thermoelements

Temperature rised on the unexposed surface: Fig. 9 -30

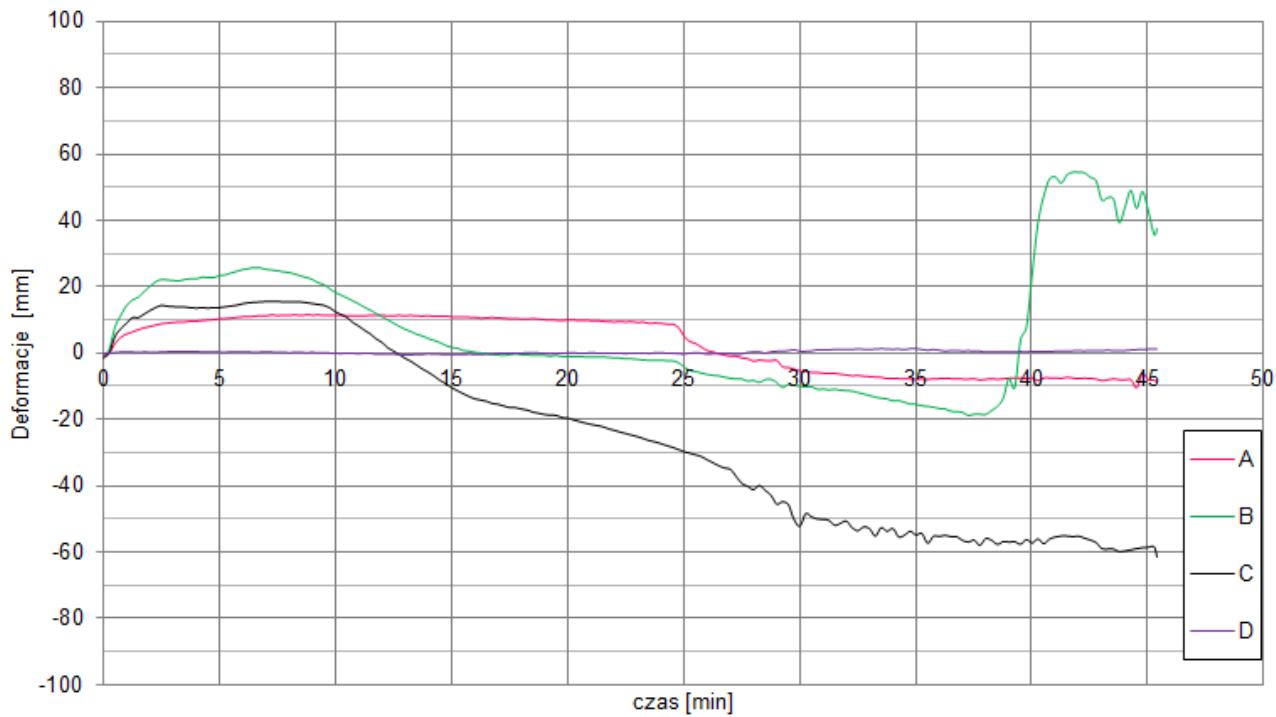
Fig. 31. Graph of deflections of the curtain wall perpendicular to its surface

Deflection towards the inside of the furnace – negative values.

Deflection towards the outside of the furnace – positive values.

The places of measurement of deflection of the curtain wall perpendicular to its surface are shown in Fig. 5. The values of the measured deflection s are presented in Fig. 31 below. .

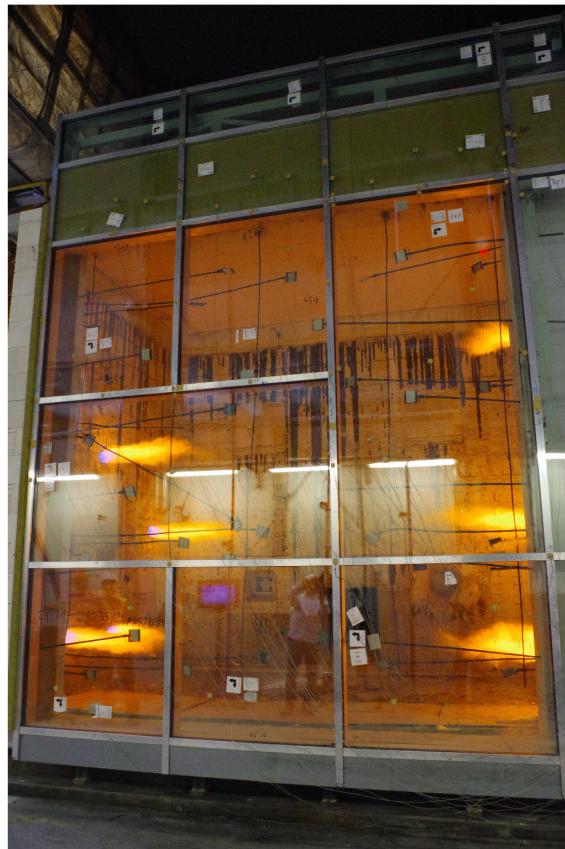
Fig. 32. Unexposed side of the test specimen, $t = 16$ m

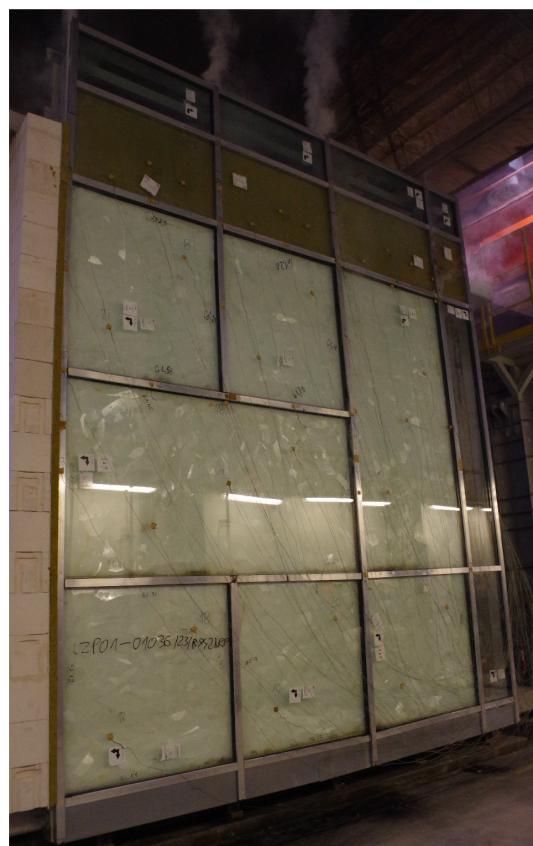
Fig. 33. Unexposed side of the test specimen, $t = 31$ m

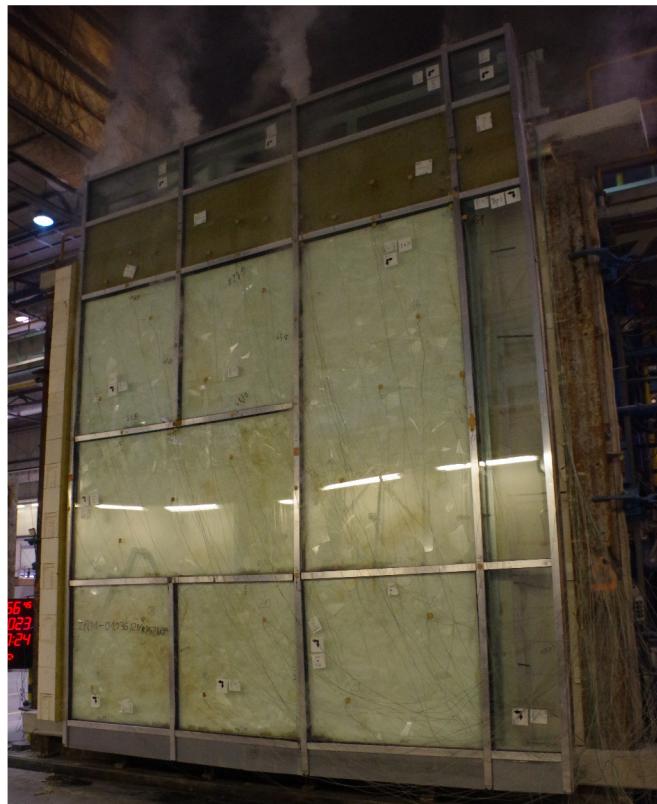
Fig. 34. Unexposed side of the test specimen, $t = 45$ m

Time	Record
0m 0s	Commencement of the test
2m 10s	Glass panes 1 – 7 non transparent (glass no. as in point 2.2.1.)
37m 01s	Smoke in right, top corner of glass pane No. 2;
45m 20s	The internal glass panes of glazings No. 4 break and fall into the furnace;
45m 23s	Termination of the test (reason: in agreement with the Client)

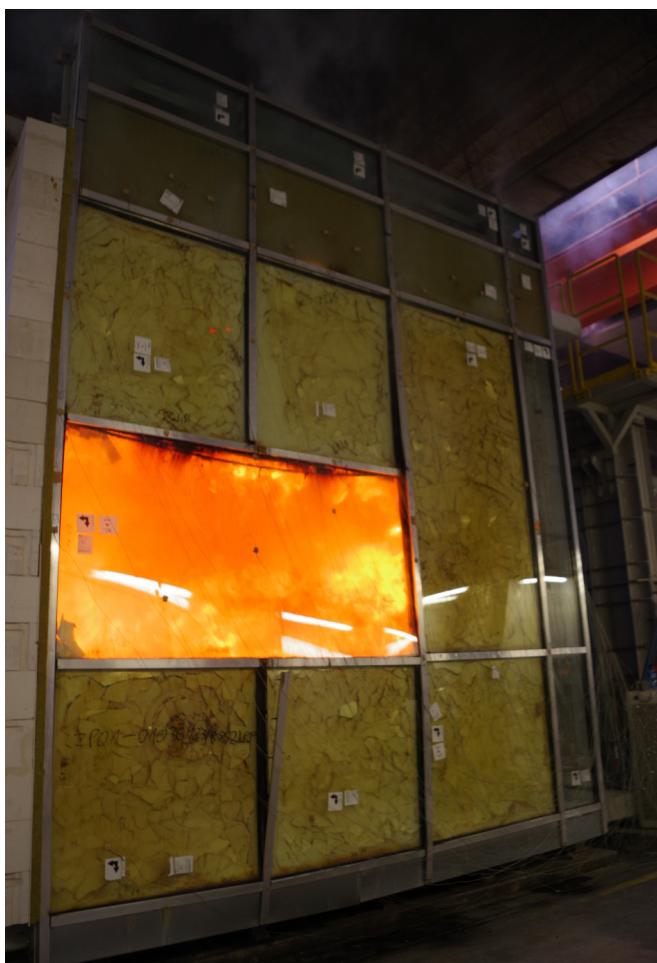
Fig. 35. Unexposed side of the test specimen after the test

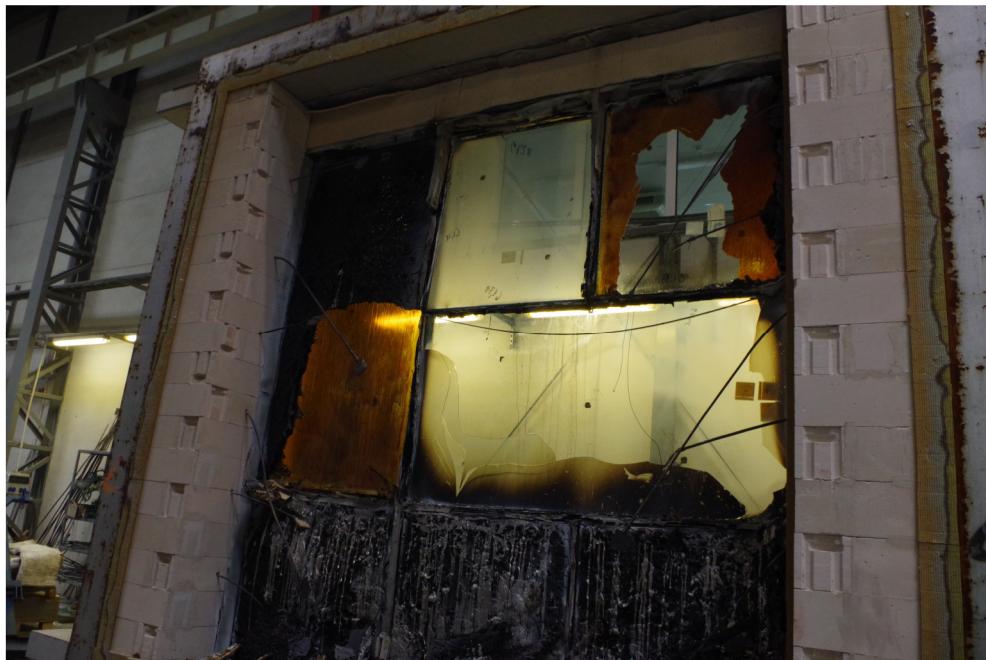
Fig. 36 Exposed side of the test specimen after the test

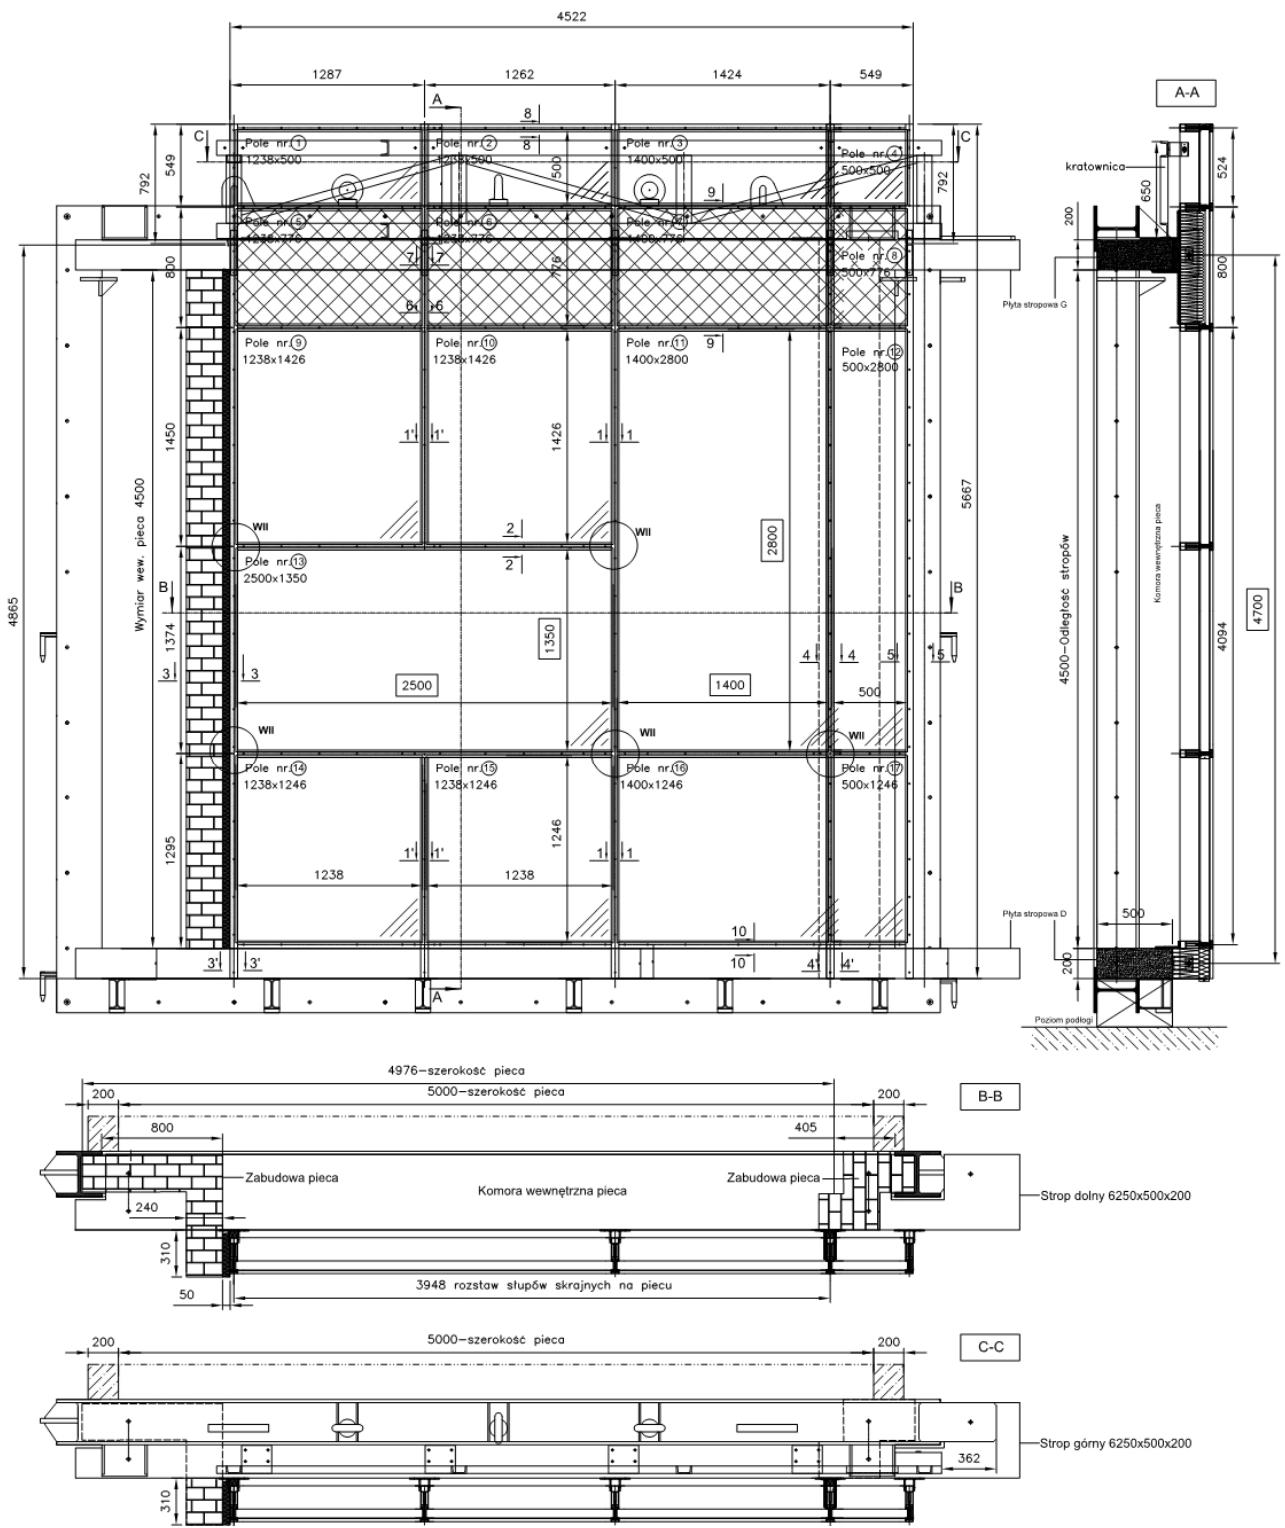
Fig. 1A. General view of the test piece, dimensions, section designation

- 4522 x 5667 mm (total dimentions),
- 3997 x 4500 mm (test specimen heated dimentions),
- 4500 mm (span length between slabs).

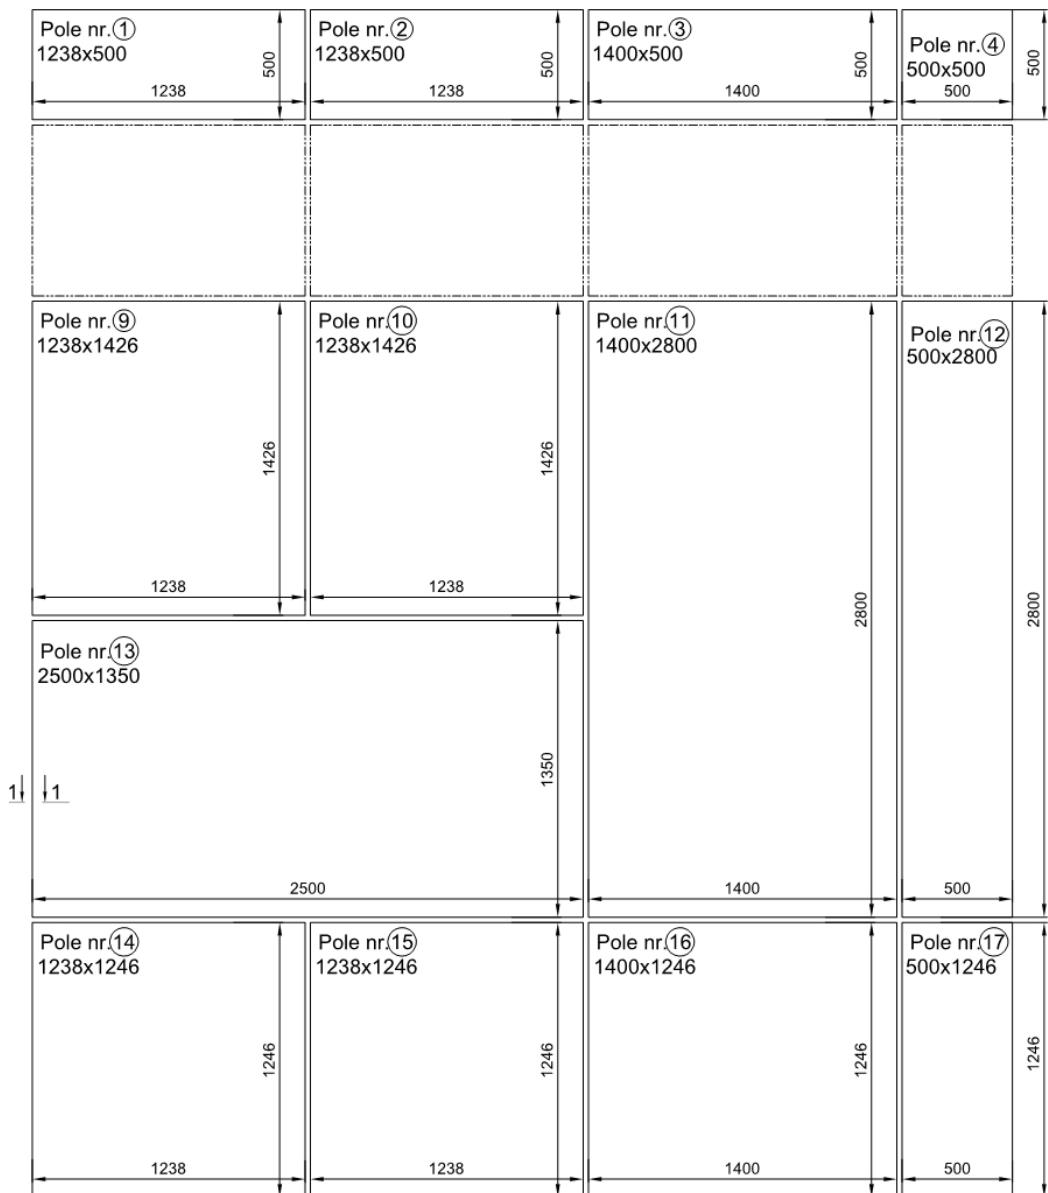
Szyba Pyrobel 16
 1. 17,3mm Pyrobel 16
 2. Spacer 16mm
 3. 6 toughened glass
 4. Spacer 16mm
 5. 6 toughened glass

Fig. 2A. Transparent fillings

- Pyrobel 16 TGU glazing units with thickness of 61,3 mm (D)/ 61,0 -62,30 (M) mm with following structure (listed from the outside): ESG 6 mm / spacer frame 16 mm / ESG 6 mm / spacer frame 16 mm / Pyrobel 16 EI30 manufactured by AGC with thickness 17,3 mm. The details of the glass dimensions and placement are shown in fig. 2A in Appendix A.
- in area of the inter-story belt, panels with following structure: glazing unit: ESG 6 mm/ spacer frame 16 mm/ ESG 6 mm; 100 mm rock wool with density of 80 kg/m³ type WENTIROCK manufactured by ROCKWOOL/ 0,80 mm steel sheet / 12,5 mm type F plasterboard.

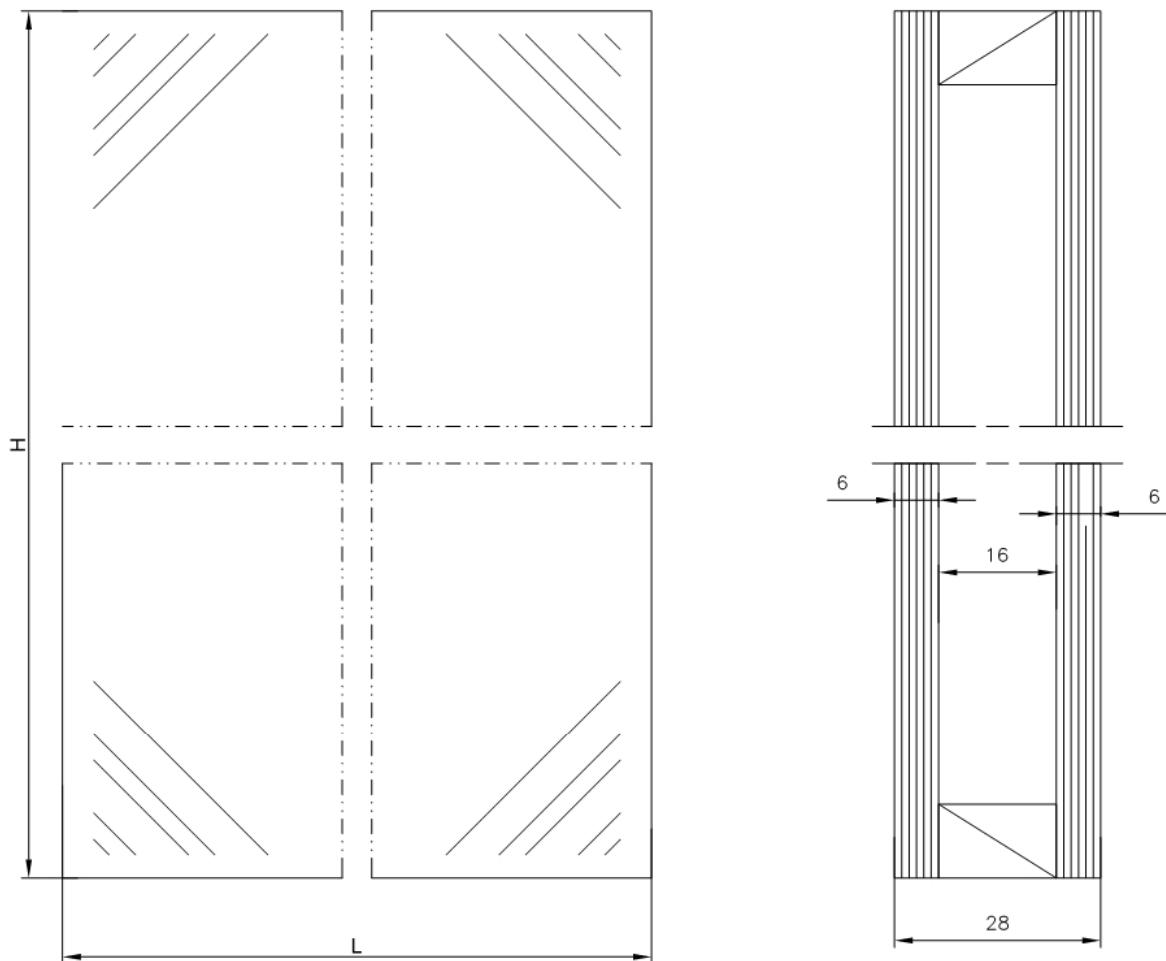
Zestawienie wymiarów szyb do badań modelu ściany osłonowej MB-SR50N EI30 od strony wewnętrznej.
Szyba jednokomorowa hartowana 2x6mm

Nr. pola	wymiar LxHxG [mm]	szt.
5,6	1238 x 776 x 28	2
7	1400 x 776 x 28	1
8	500 x 776 x 28	1

Fig. 3A. Glass panes in non transparent fillings

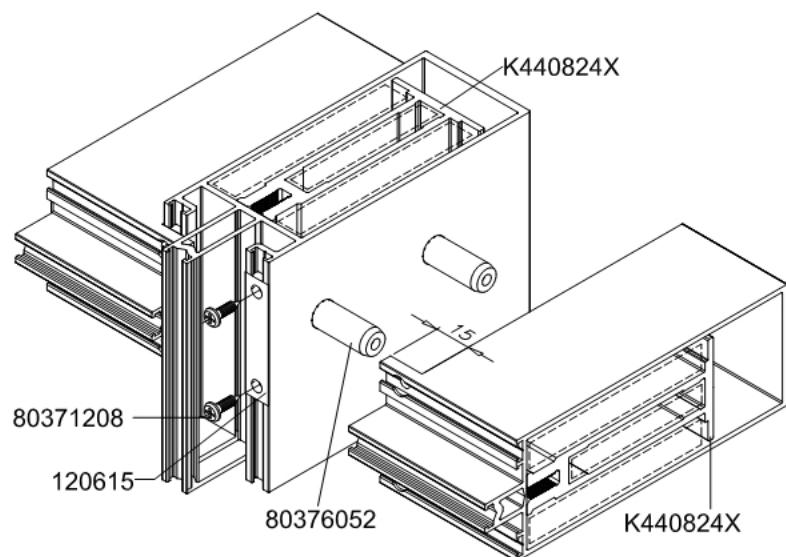
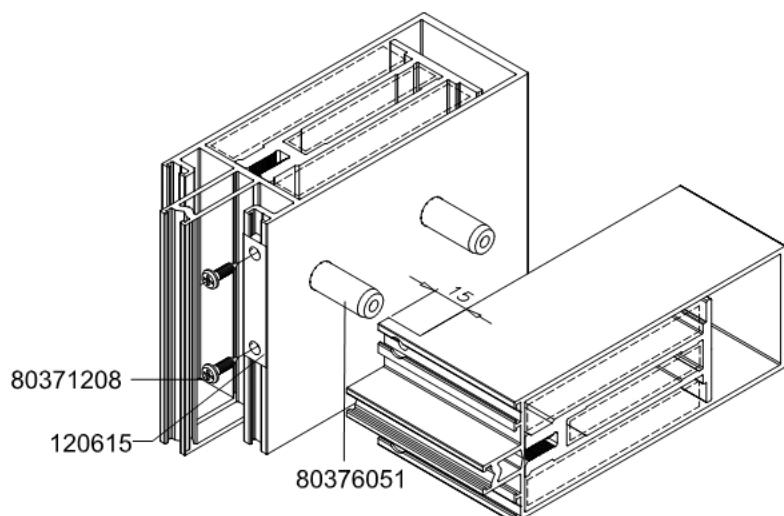
Fig 17A. Schemes of making transom - mullion connections

The reinforcement inserts were connected to mullions and transoms with steel connectors cat. No. 80312107 (transom) and 80312108 (mullion). The mullions and transoms were connected with overlap and by additional steel connectors cat. No. 80376051 and 80376052 (one-sided and double-sided respectively) mounted to mullions on which transoms were shoved.

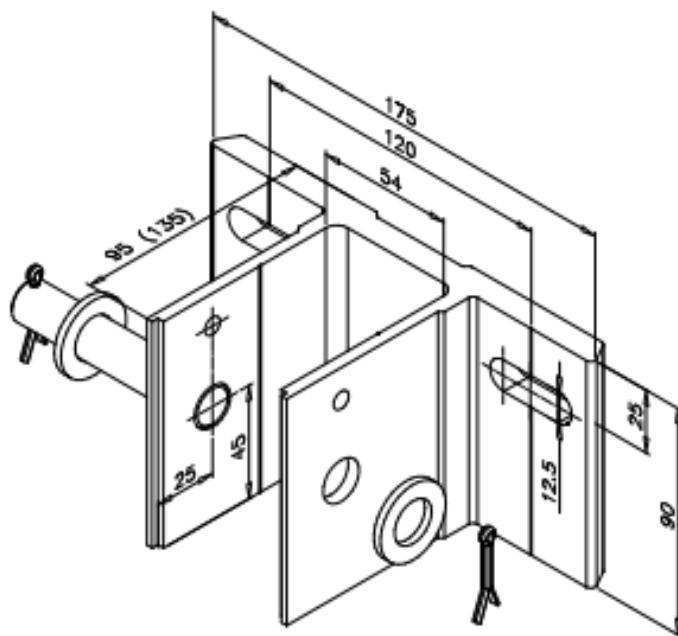
Rys. 18A. Fixed bracket cat. No. 80002127

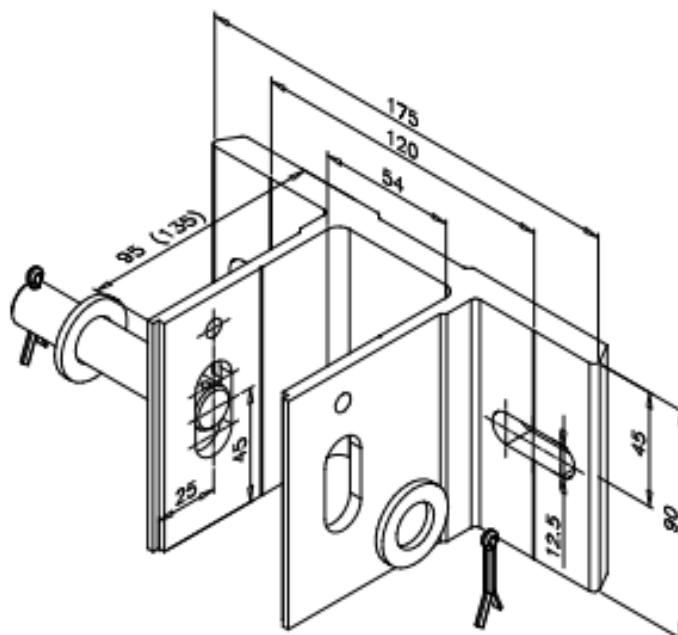
Rys. 19A. Sliding bracket cat. No. 80002128

The connection of the curtain wall of the MB-SR50N EI type EI 30 system with the steel frame was made by means of aluminum sliding brackets 1D (135 mm) cat. No. 80002128 thickness of 5.7 mm, connected to the mullions through steel sleeves with M12 x 95 mm screws. The aluminum brackets were connected to the steel C-section with M12 x 45 mm steel bolts, washers and nuts.
